# Mystic Pointe Tower 500 Condominium

3530 Mystic Pointe Drive, Aventura, FL 33180

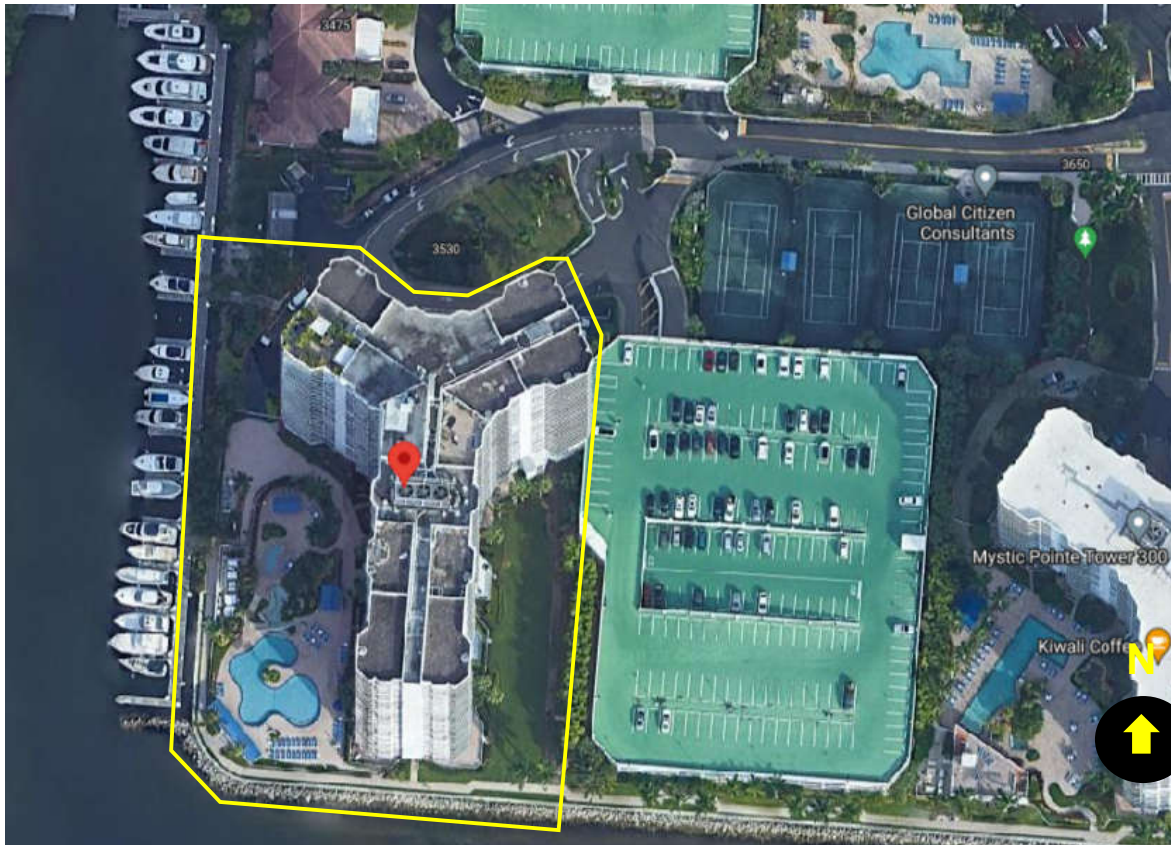
Figure 1: Site Plan with location of the property – Aerial Photography from Miami Dade Property Appraiser

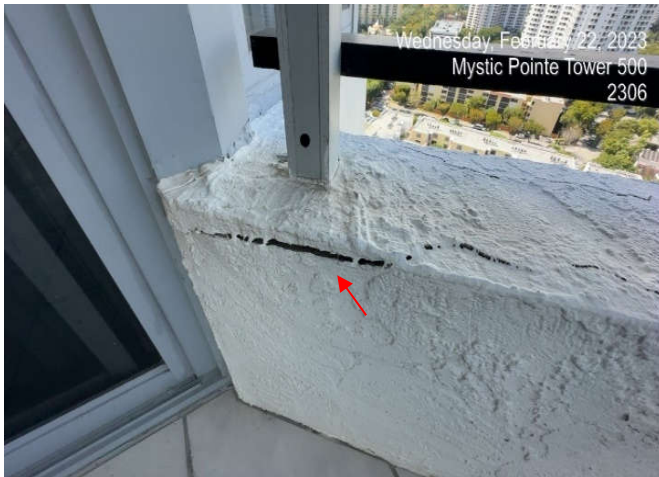
Photo 7.1.a.1 – Cracked concrete / stucco with hollow sound at balcony knee wall adjacent to the post pocket (Unit 2306)

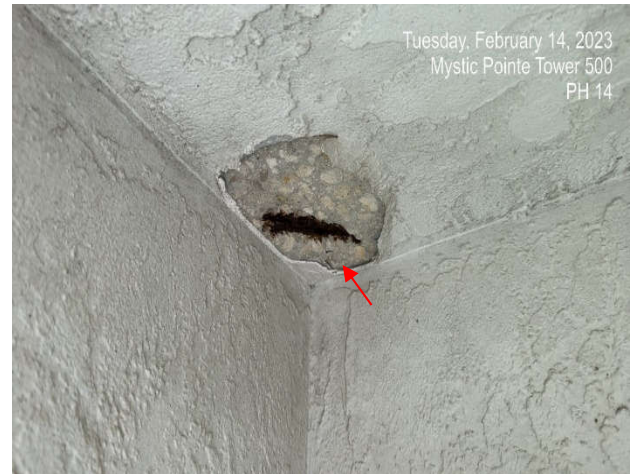
Photo 7.1.a.2 – Spalled concrete and exposed corroded rebar at the corner of balcony ceiling (PH 14)

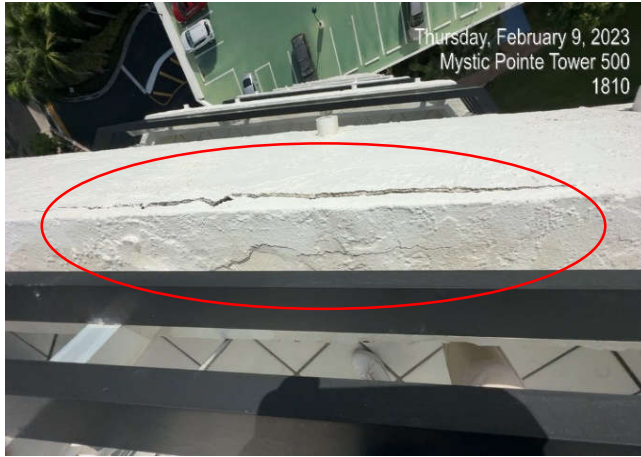
Photo 7.1. a.3 – Cracked concrete and hollow sound at balcony knee wall (Unit 1810)

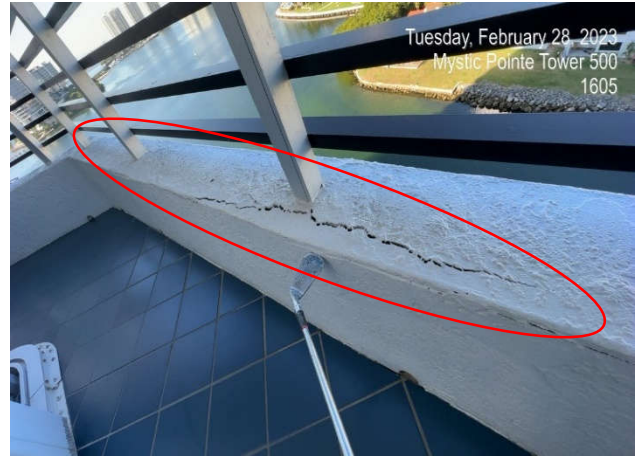
Photo 7.1.a.4 – Cracked concrete with hollow sound at balcony knee wall adjacent to the post pocket (Unit 1605)

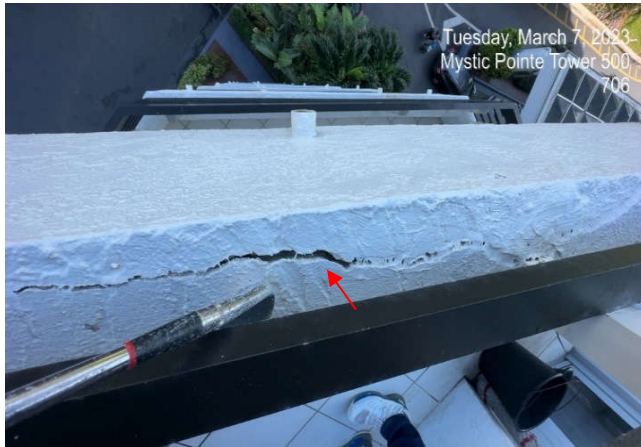
Photo 7.1.a.5 – Cracked concrete with hollow sound at balcony knee wall (Unit 706)

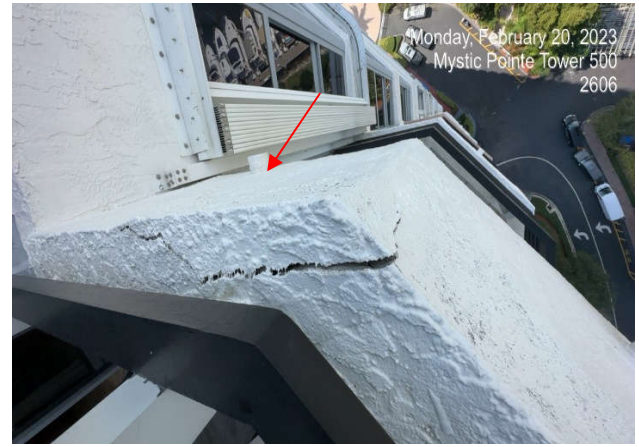
Photo 7.1.a.6 – Cracked concrete and hollow sound at balcony knee wall (Unit 2606)

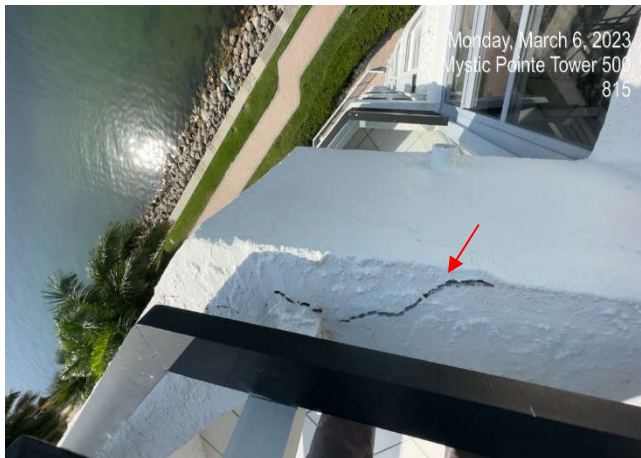
Photo 7.1.a.7 – Cracked concrete at balcony knee wall and hollow sound (Unit 815)

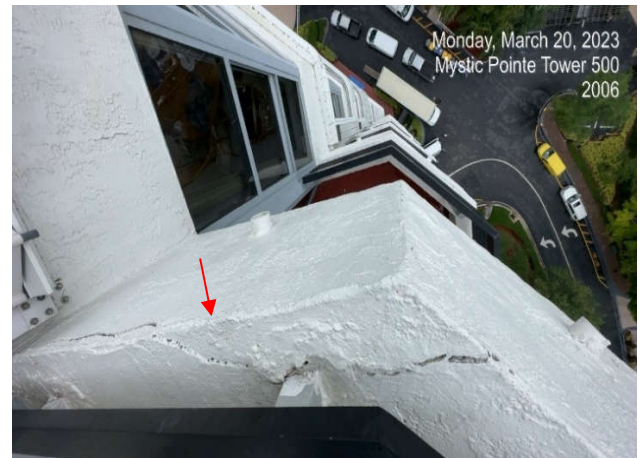
Photo 7.1.a.8 – Cracked concrete and hollow sound at balcony knee wall adjacent to the post pocket (Unit 2006)

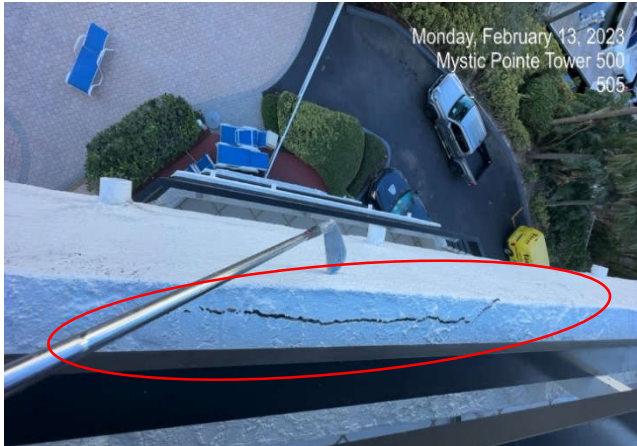
Photo 7.1.a.11 – Cracked concrete and hollow sound at balcony knee wall (Unit 505)

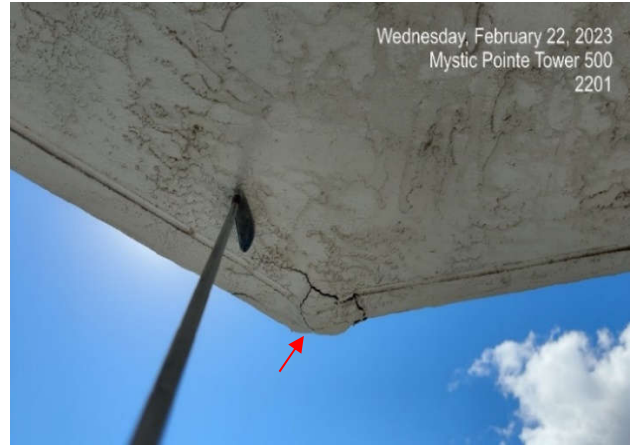
Photo 7.1.a.12 – Cracked concrete and initial stage of detachment at edge of balcony ceiling (Unit 2201)

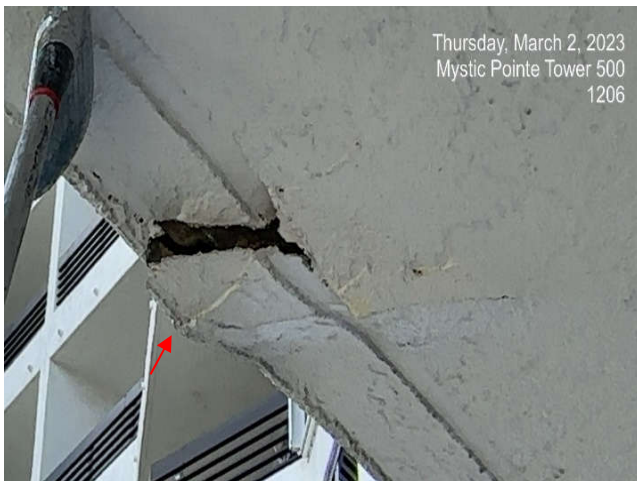
Photo 7.1.a.13 – Spalled concrete with exposed corroded rebar and initial stage of detachment at balcony ceiling (Unit 1206)

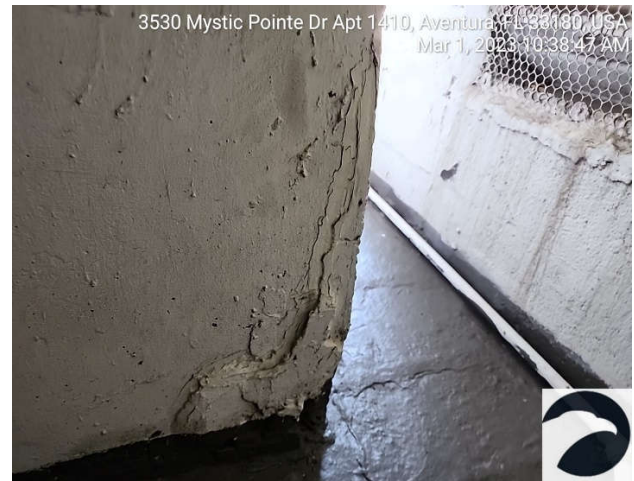
Photo 7.1.a.14 – Cracked concrete with hollow sound at column of the A/C Mechanical Room (Roof Level)

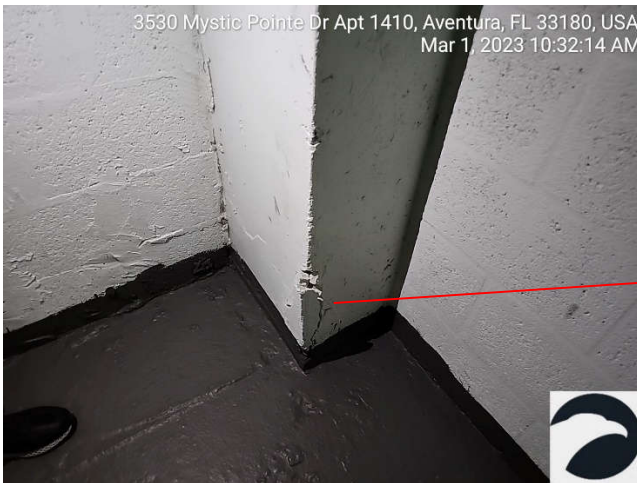
Photo 7.1.a.15 – Spalled concrete at column of the A/C Mechanical Room (Roof Level)

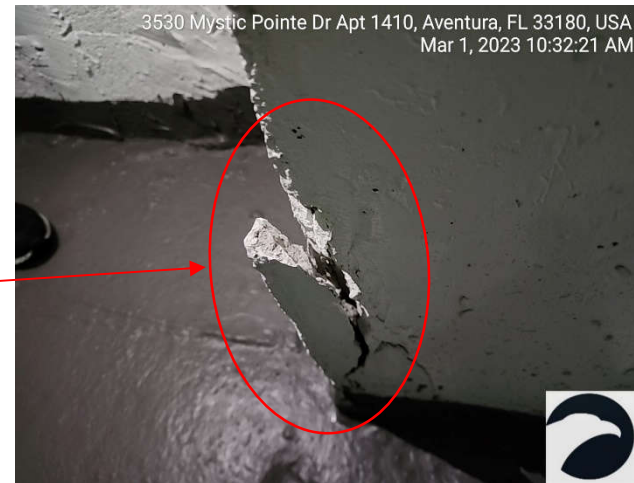
Photo 7.1.a.16 – Spalled concrete at column of the A/C Mechanical Room (Roof Level)

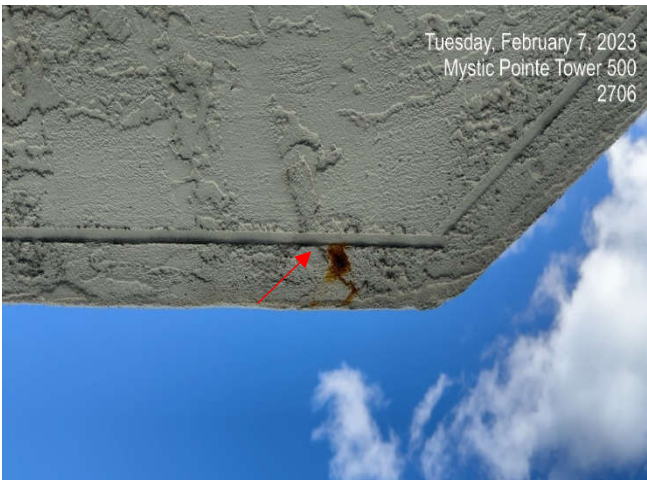
Photo 7.1.b.1 – Rust spot at the balcony ceiling (Unit 2706)

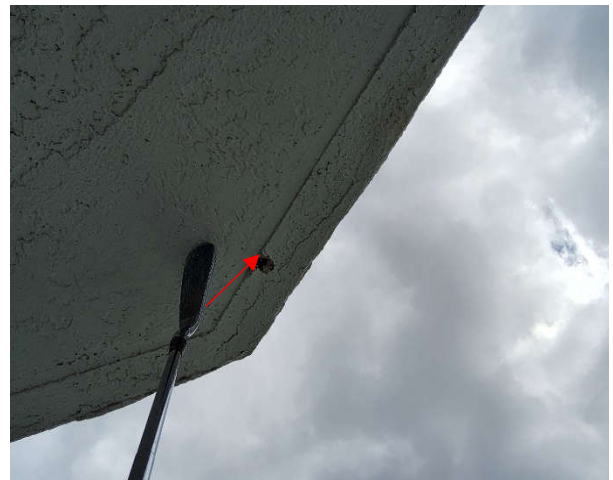
Photo 7.1.b.2 – Rust spot at the balcony ceiling (Unit 2010)

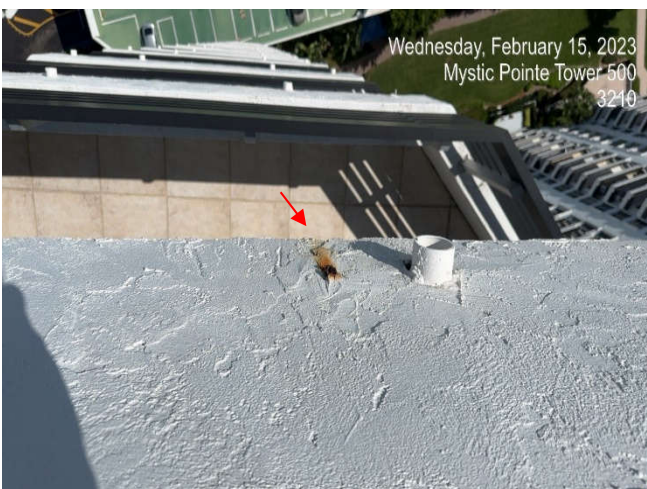
Photo 7.1.b.3 – Rust spot at the balcony knee wall (Unit 3210)

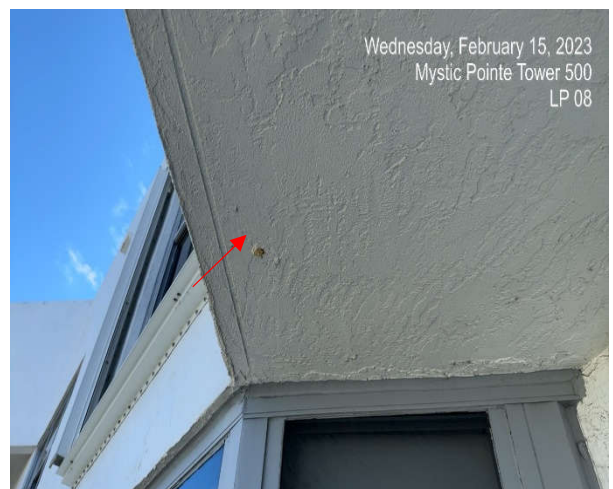
Photo 7.1.b.4 – Rust spot at the balcony ceiling (LP 08)

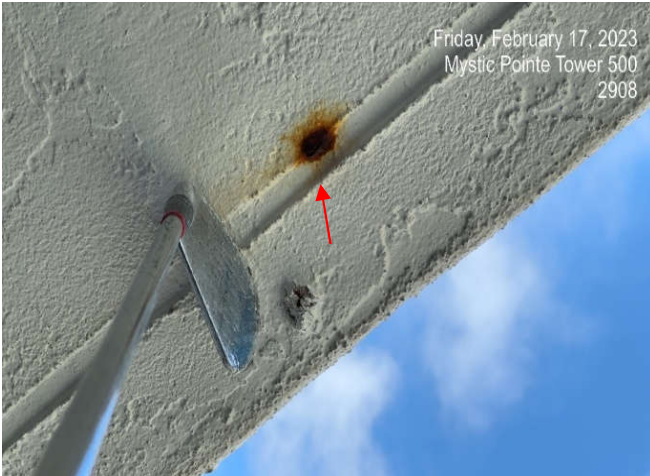
Photo 7.1.b.5 – Rust spot at the balcony ceiling (Unit 2908)

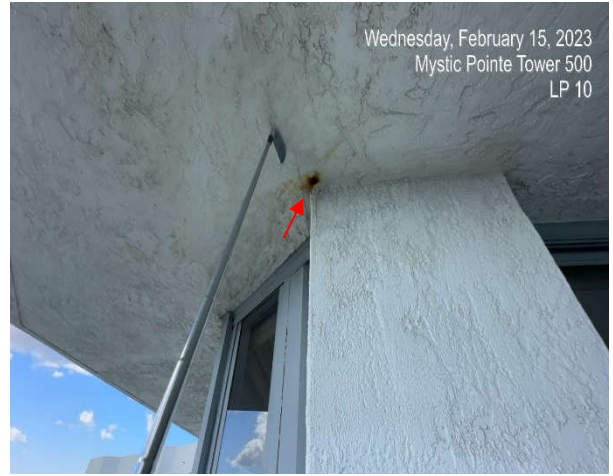
Photo 7.1.b.6 – Rust spot at the balcony ceiling (LP 10)

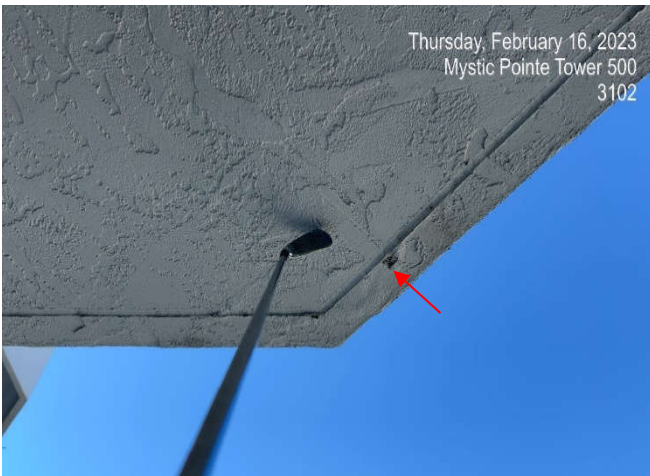
Photo 7.1.b.7 – Rust spot at the balcony ceiling (Unit 3102)

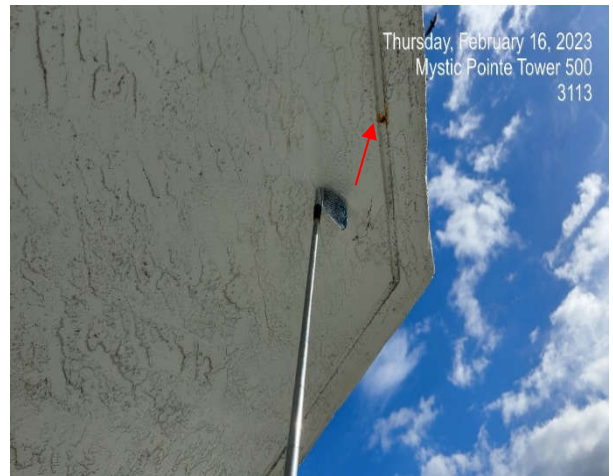
Photo 7.1.b.8 – Rust spot at the balcony ceiling (Unit 3113)

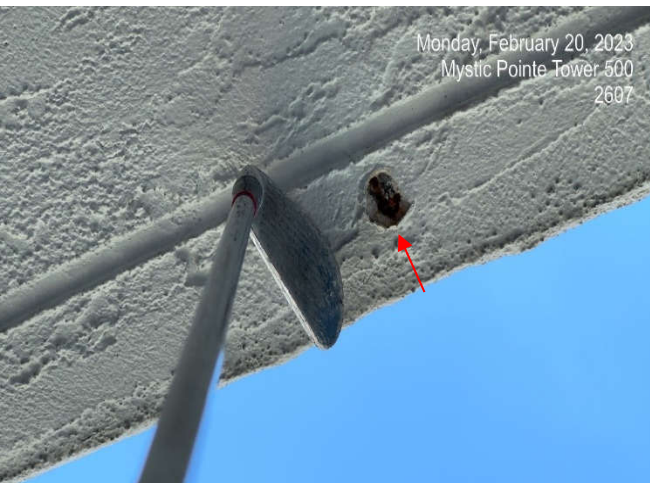
Photo 7.1.b.9 – Rust spot at the balcony ceiling (Unit 2607)

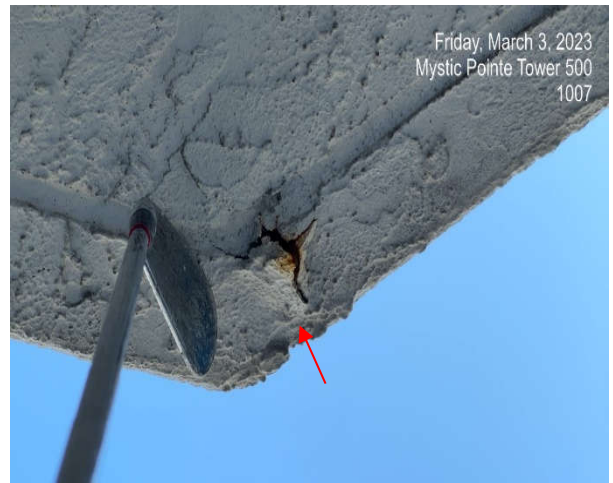
Photo 7.1.b.10 – Rust spot at balcony ceiling and initial stage of concrete / stucco delamination (Unit 1007)

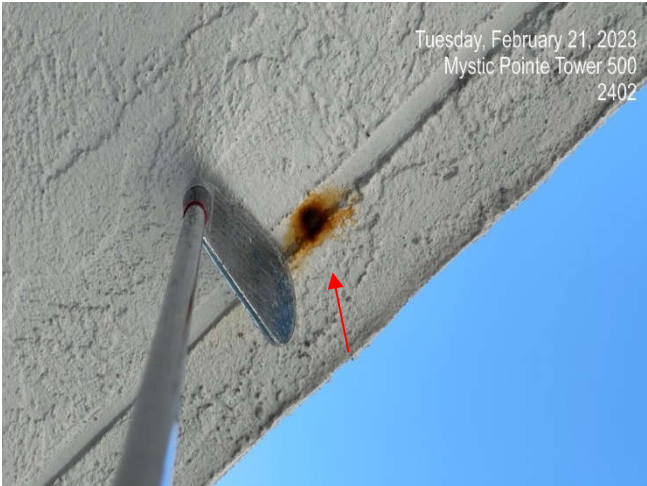
Photo 7.1.b.11 – Rust spot at the balcony ceiling (Unit 2402)

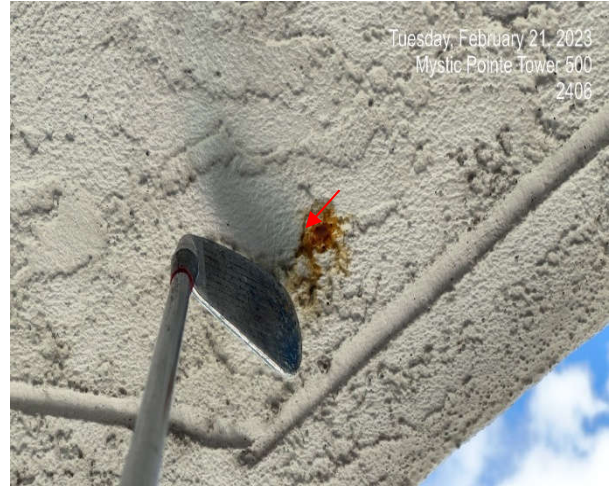
Photo 7.1.b.12 – Rust spot at the balcony ceiling (Unit 2406)

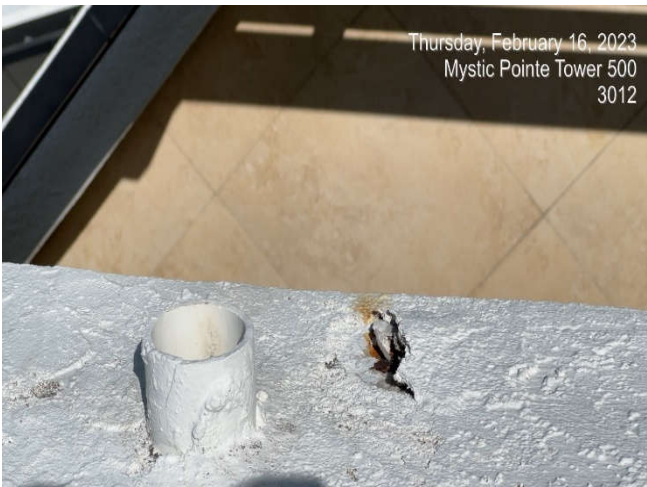
Photo 7.1.b.15 – Rust spot at balcony knee wall (Unit 3012)

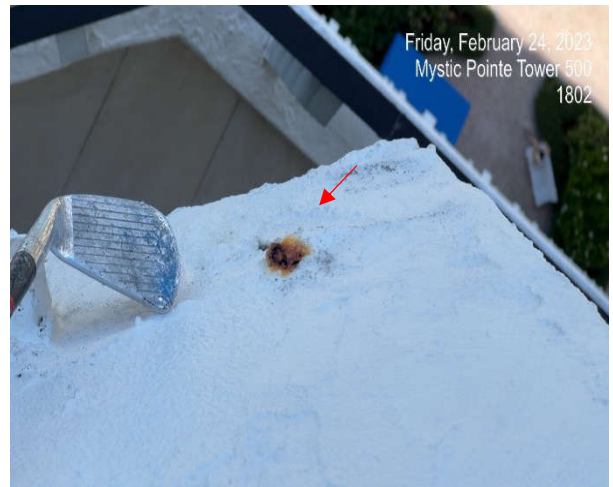
Photo 7.1.b.16 – Rust spot at balcony knee wall (Unit 1802)

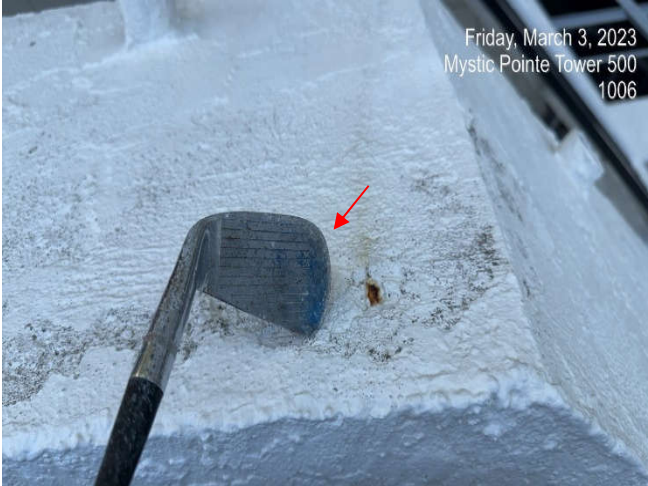
Photo 7.1.b.17 – Rust spot at balcony knee wall (Unit 1006)

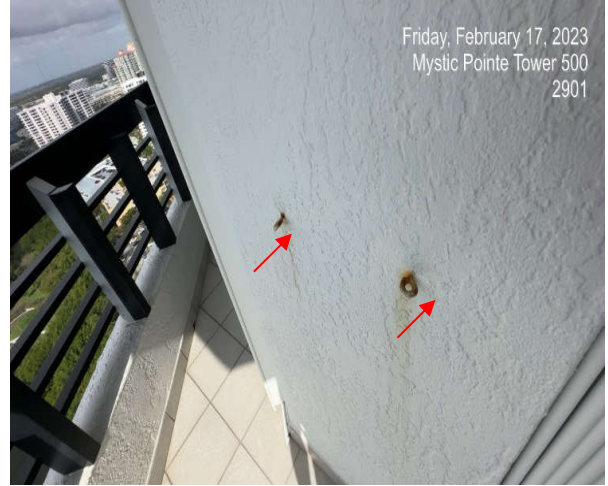
Photo 7.1.b.18 – Corroded embedded metal at balcony wall (Unit 2901)

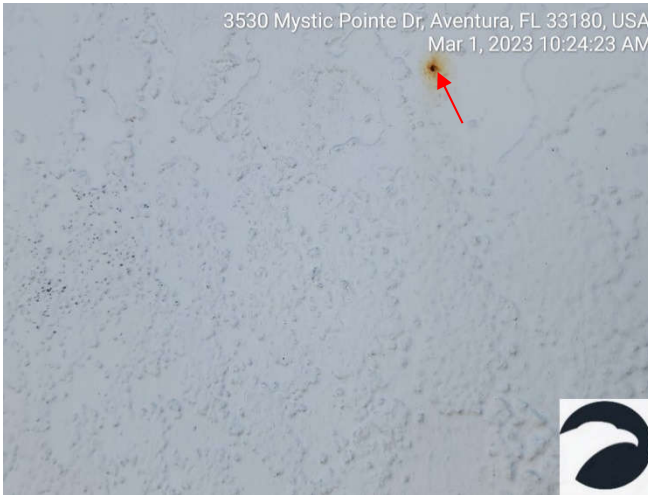
Photo 7.1.b.19 – Rust spot at parapet wall (Roof Level)

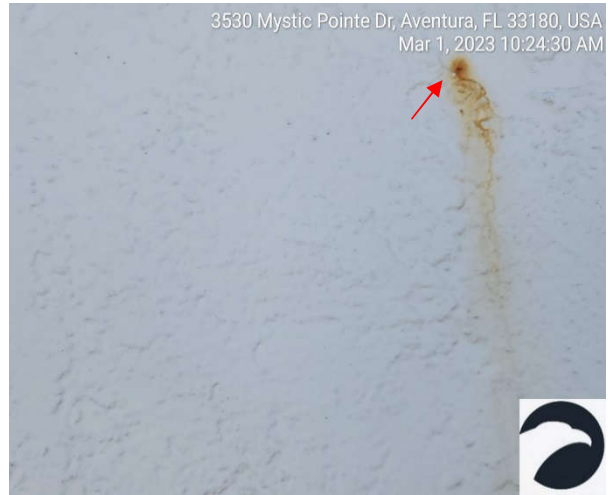
Photo 7.1.b.20 – Rust spot at parapet wall (Roof Level)

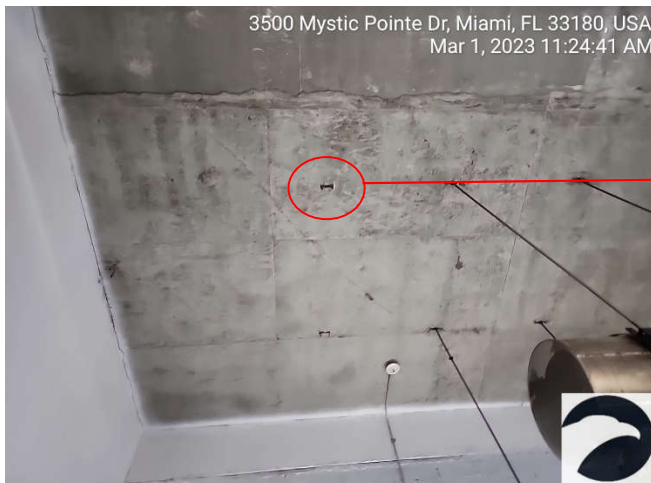
Photo 7.1.b.21 – Corroded embedded metal at ceiling of the Generator Room (Ground Level)

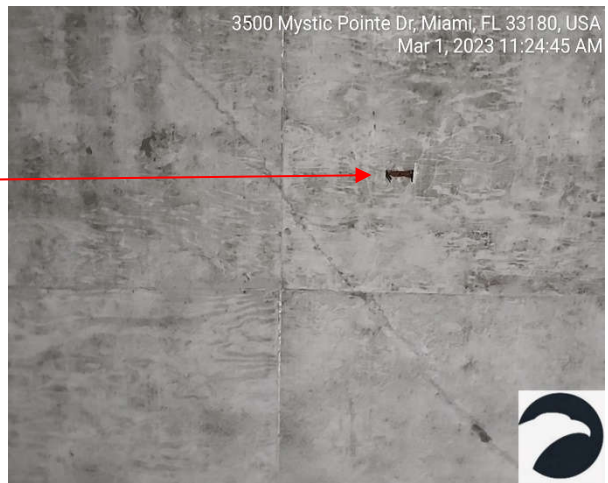
Photo 7.1.b.22 – Corroded embedded metal at ceiling of the Generator Room (Ground Level)

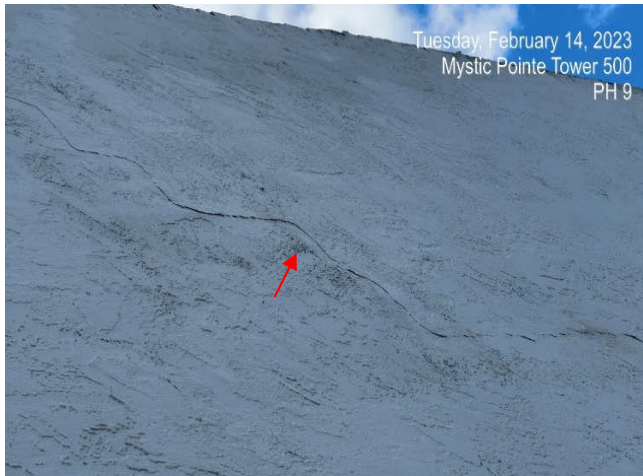
Photo 7.1.c.1–Stair-step crack at exterior CMU parapet wall (PH 09)

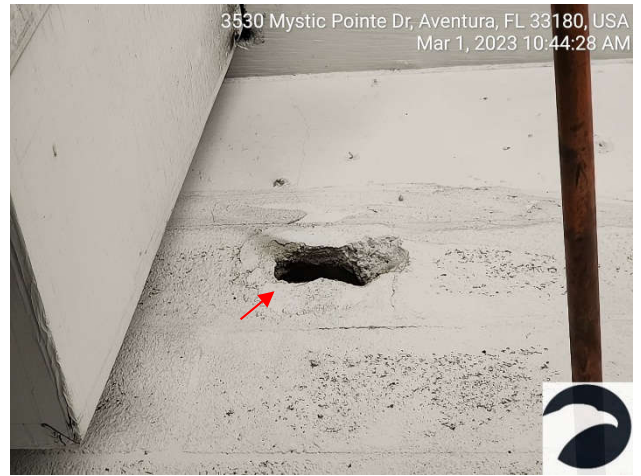
Photo 7.1.c.2 – Damaged CMU wall at interior of the A/C Mechanical Room (Roof Level)

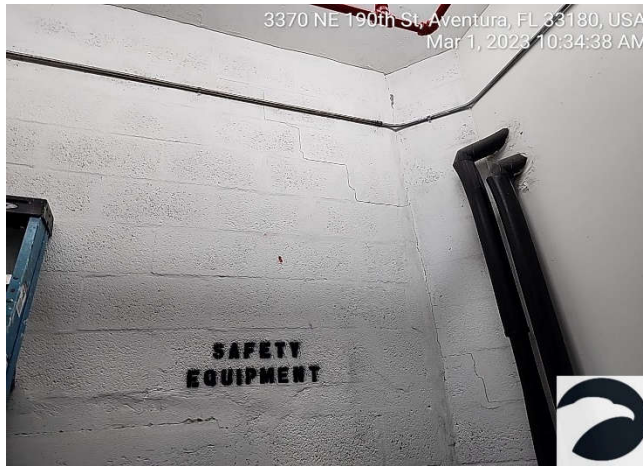
Photo 7.1.c.3 – Stair-step crack at interior CMU of the A/C Mechanical Room (Roof Level)

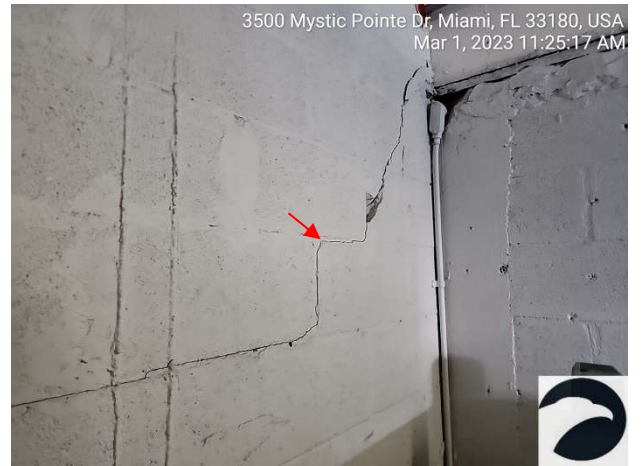
Photo 7.1.c.4 – Stair-step crack at exterior CMU parapet wall of the Emergency Generator Room (Ground Level)

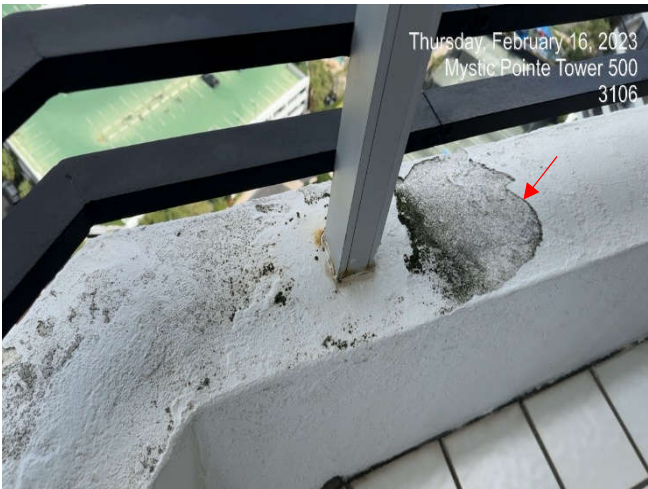
Photo 7.2.a.1 – Peeled paint and mold at balcony knee wall (Unit 3106)

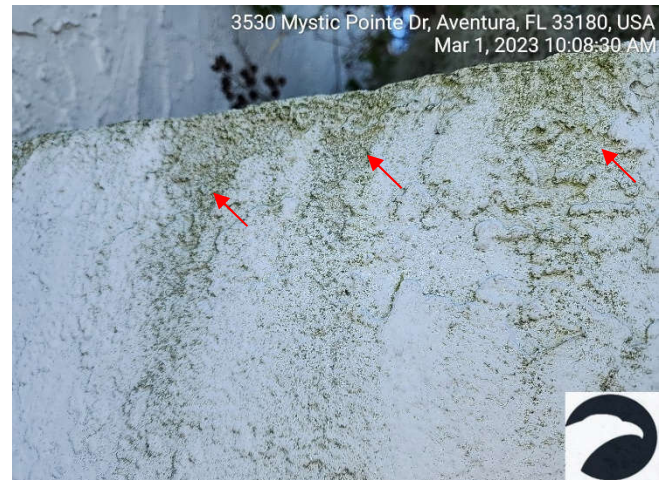
Photo 7.2.a.4 – Stained paint with biological growth at parapet wall (Roof Level)

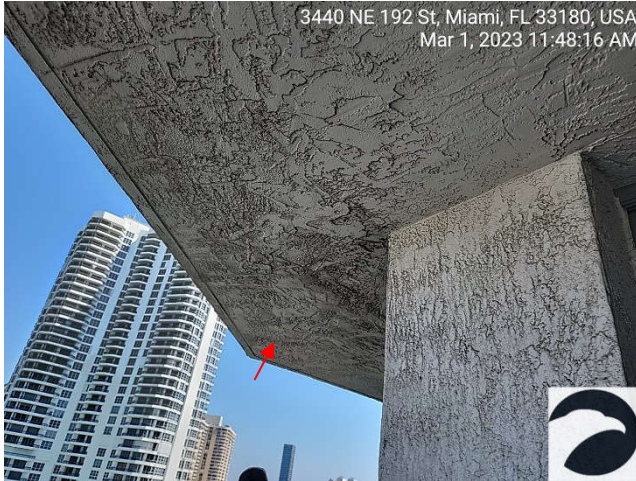
Photo 7.2.a.5 – Dirty paint at ceiling and walls of the balcony (Unit 3106)

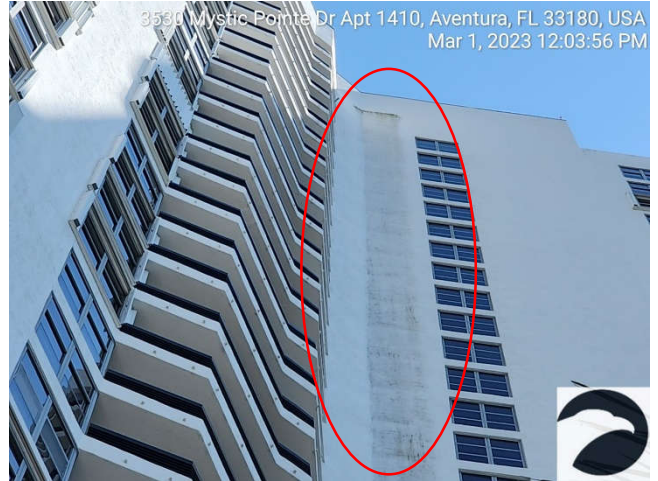
Photo 7.2.a.6 – Stained paint at exterior wall from the Mechanical Room Level (West Facade)

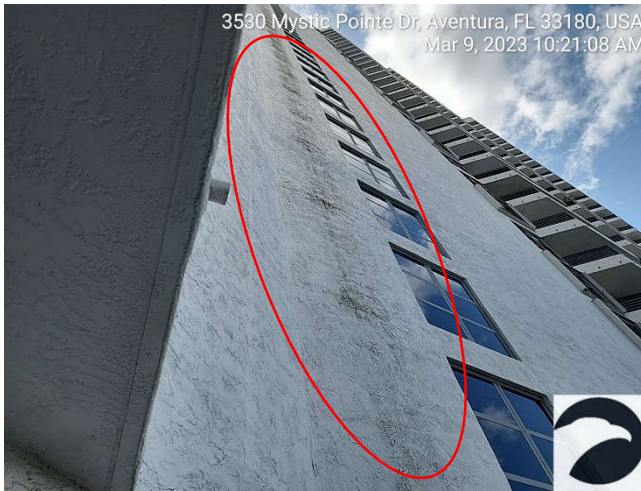
Photo 7.2.a.7 – Stained paint at exterior wall from the Mechanical Room Level (West Facade)

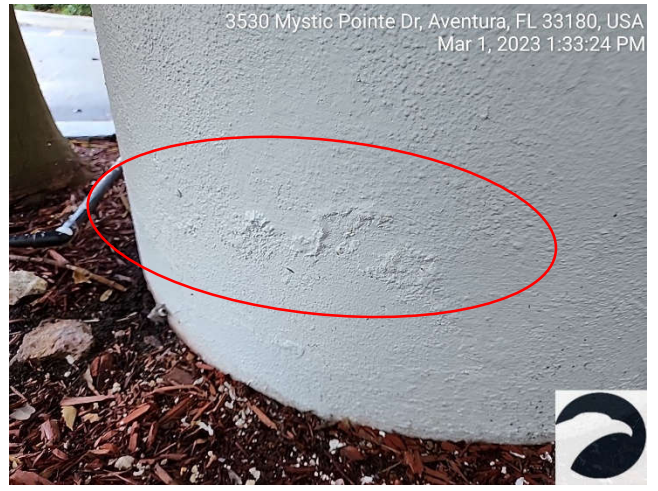
Photo 7.2.a.8 – Peeling and blistering paint at column of the Entry Lobby (Ground Level)

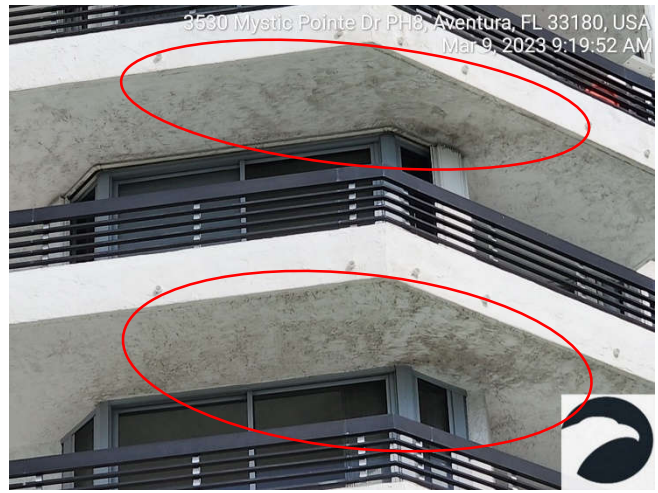
Photo 7.2.a.10 – Dirty paint at ceiling and walls of the balcony (West Facade)

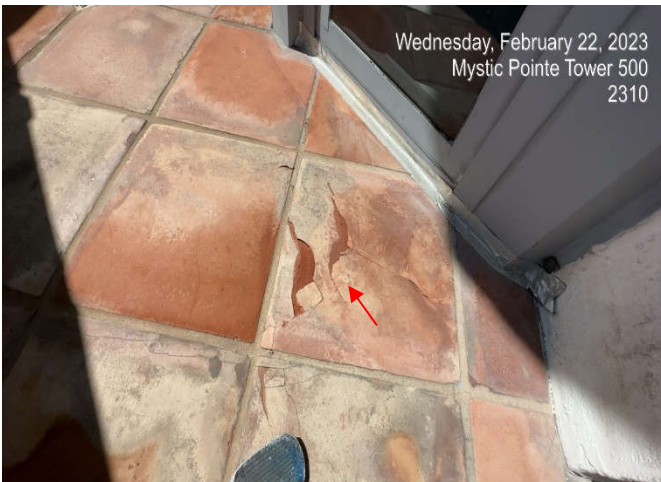
Photo 7.2.b.1 – Hollow and cracked tile at balcony floor (Unit 2310)

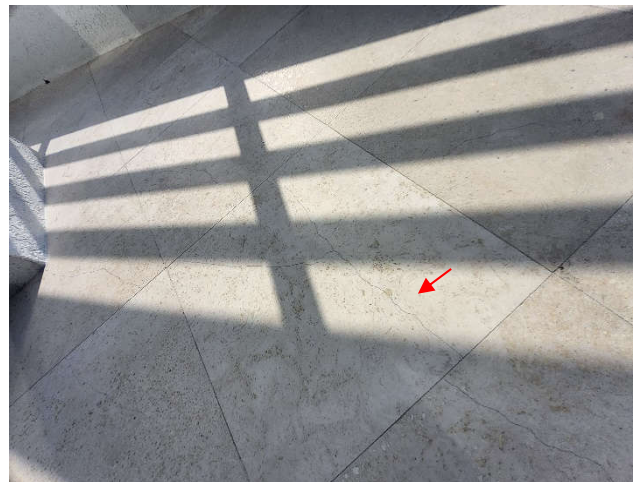
Photo 7.2.b.2 – Cracked tiled at balcony floor (Unit 2805)

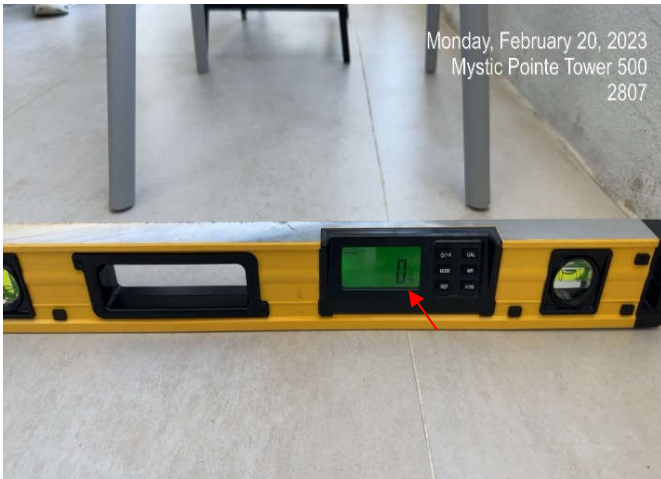
Photo 7.2.b.3 – Zero slope at the balcony floor (Unit 2807)

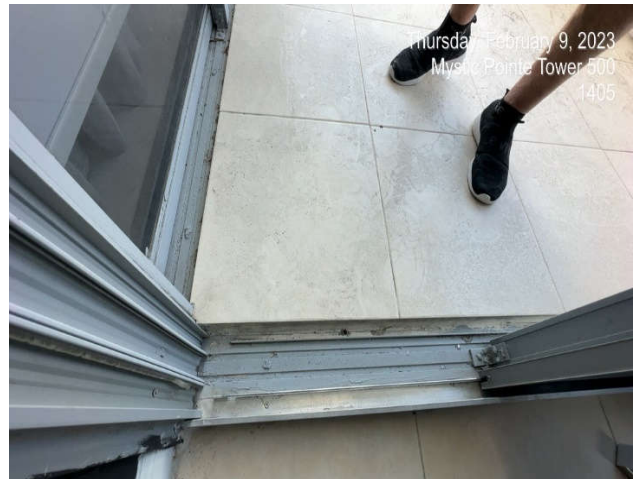
Photo 7.2.b.4 – Tiles level is above the sliding glass door frame level (Unit 1405)

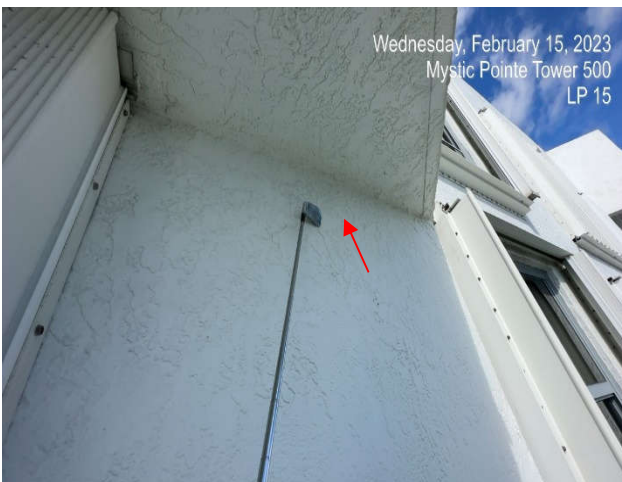
Photo 7.2.c.1 – Hollow sound and stucco delamination at balcony wall (LP 15)

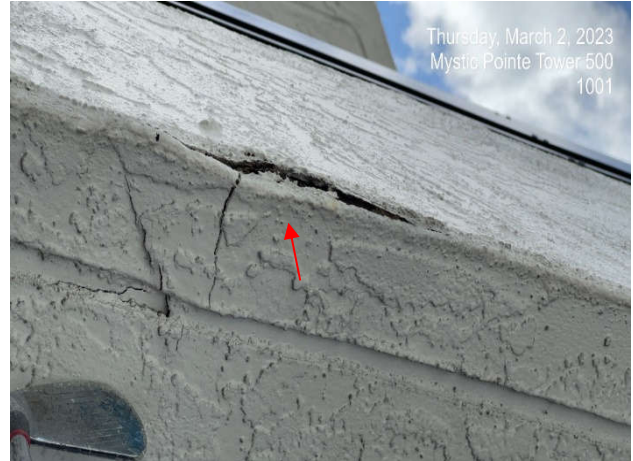
Photo 7.2.c.10 – Cracked and initial stage of detachment at ceiling of the balcony (Unit 1001)

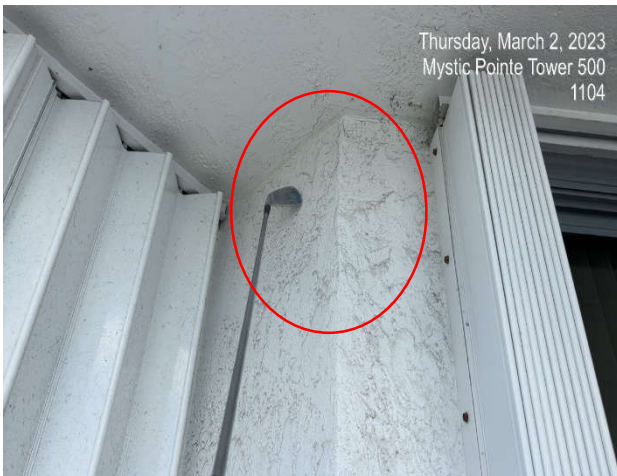
Photo 7.2.c.11 – Hollow sound and stucco delamination at balcony wall (Unit 1104)

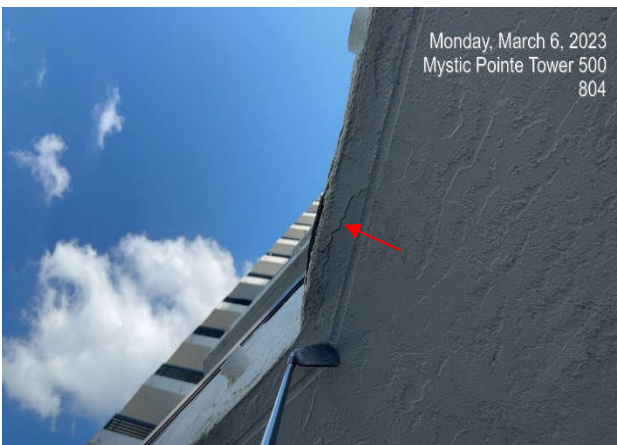
Photo 7.2.c.13 – Cracked stucco and initial stage of detachment at edge of the balcony ceiling (Unit 804)

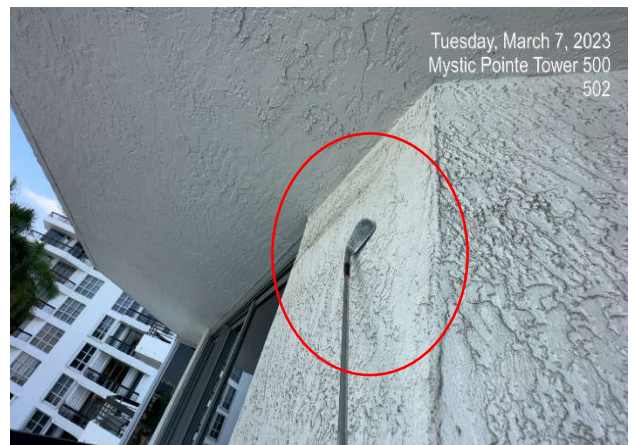
Photo 7.2.c.14 – Hollow and stucco delamination at balcony wall (Unit 502)

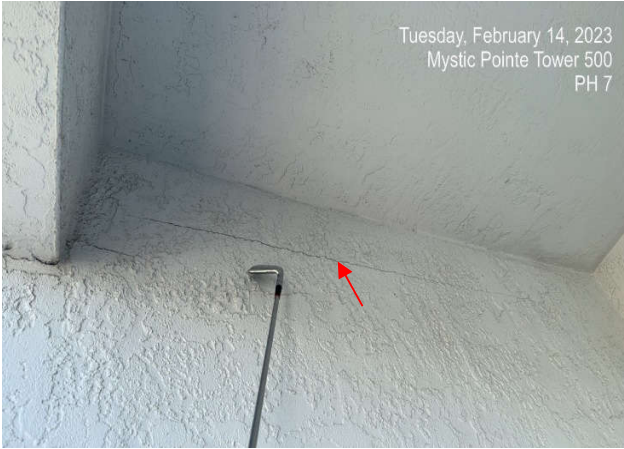
Photo 7.2.c.15 – Cracked stucco at balcony wall (PH 07)

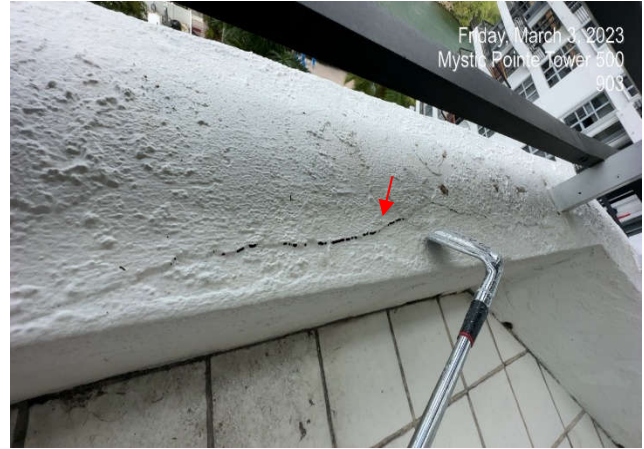
Photo 7.2.c.16 – Cracked stucco with hollow sound at balcony knee wall (Unit 903)

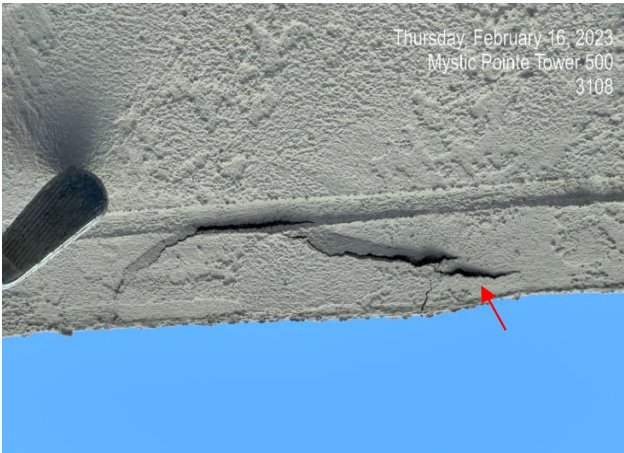
Photo 7.2.c.17 – Cracked stucco and initial stage of detachment at balcony ceiling (Unit 3108)

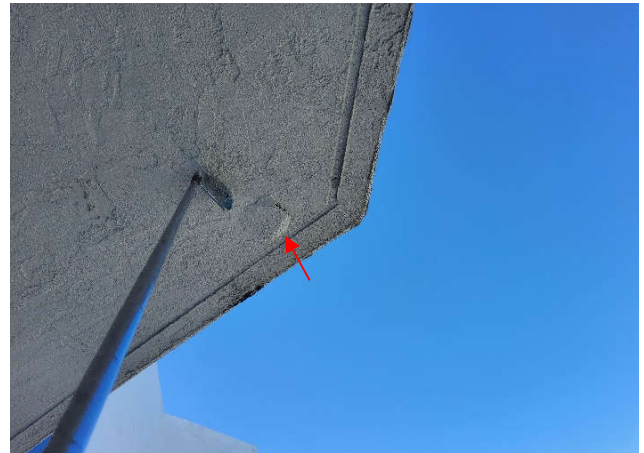
Photo 7.2.c.18 – Initial stage of stucco detachment at balcony wall (Unit 814)

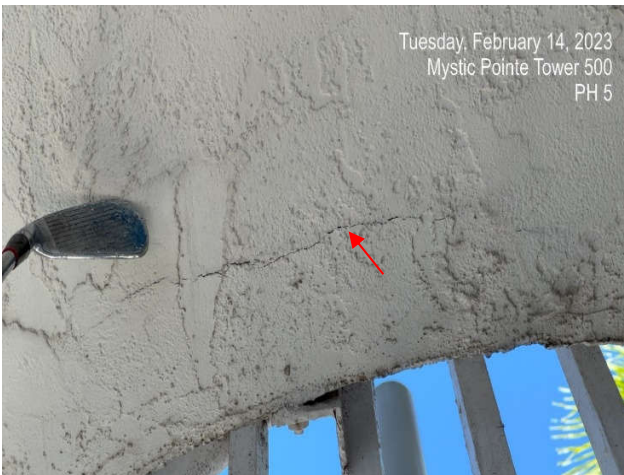
Photo 7.2.c.19 – Cracked stucco at balcony ceiling (PH 05)

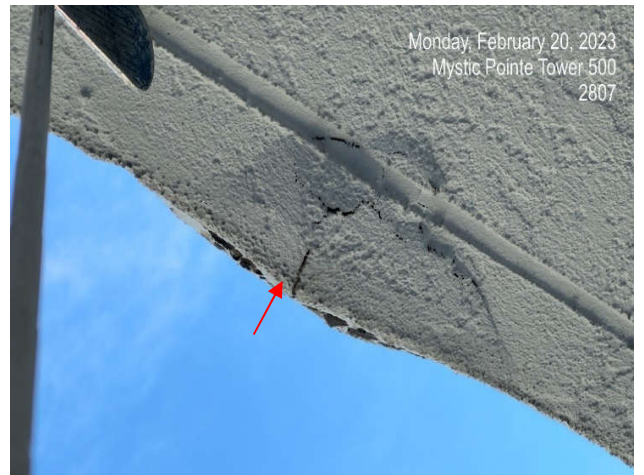
Photo 7.2.c.20 – Cracked stucco and initial stage of detachment at edge of the balcony ceiling (Unit 2807)

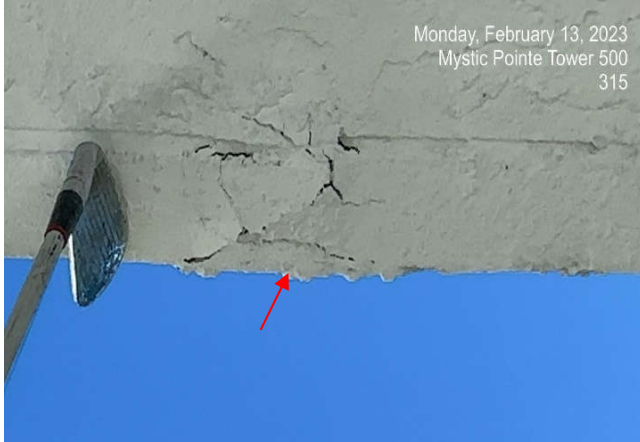
Monday, February 13, 2023  
Mystic Pointe Tower 500  
315  
**Photo 7.1.c.21 – Cracked stucco and initial stage of detachment at edge of the balcony ceiling (Unit 315)**

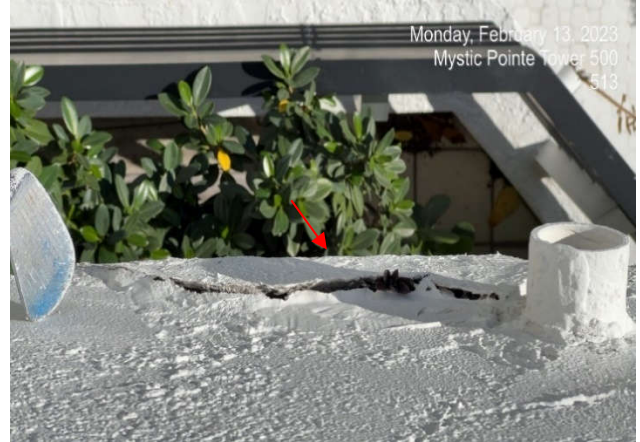
Monday, February 13, 2023  
Mystic Pointe Tower 500  
513  
**Photo 7.1.c.22 – Cracked stucco and evidence of biological growth at balcony knee wall adjacent to the scupper (Unit 513)**

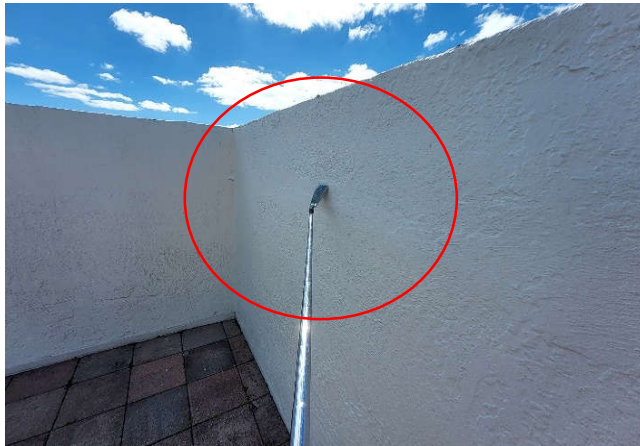
**Photo 7.2.c.23 – Stucco delamination and hollow sound at parapet wall (Unit 1513)**

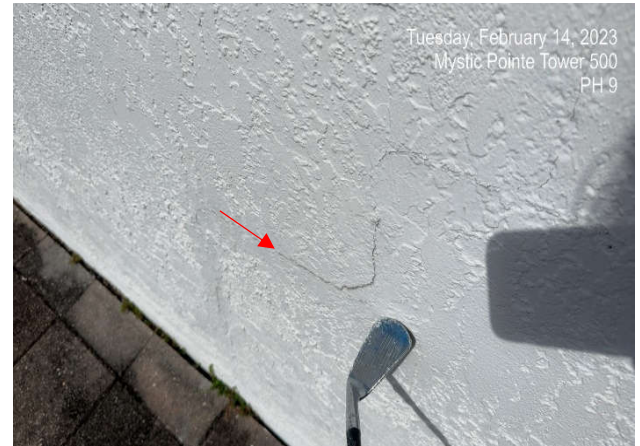
Tuesday, February 14, 2023  
Mystic Pointe Tower 500  
PH 9  
**Photo 7.2.c.24 – Cracked stucco and hollow sound at parapet wall (Unit PH 09)**

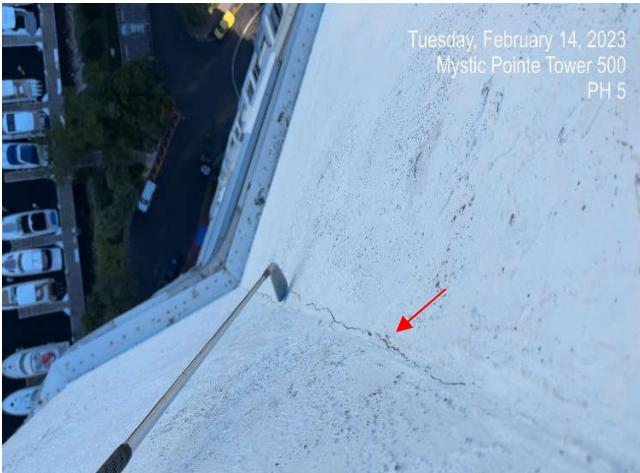
Tuesday, February 14, 2023  
Mystic Pointe Tower 500  
PH 5  
**Photo 7.2.c.25 – Cracked stucco at exterior side of the parapet wall (Unit PH 05)**

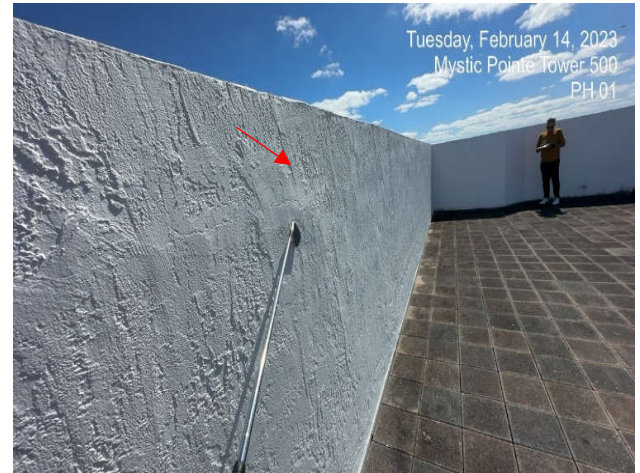
Tuesday, February 14, 2023  
Mystic Pointe Tower 500  
PH 01  
**Photo 7.2.c.26 – Cracked stucco and hollow sound at parapet wall (Unit PH 01)**

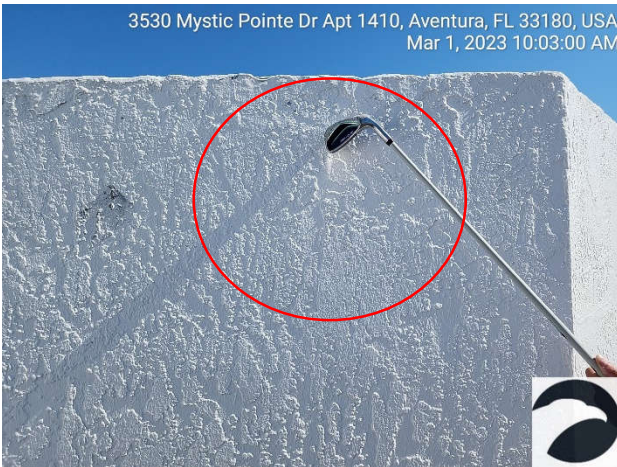
Photo 7.2.c.27– Delaminated stucco, hollow sound at parapet wall (Roof Level)

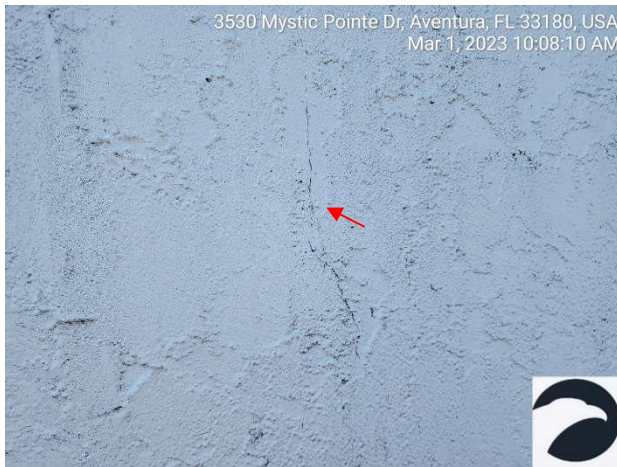
Photo 7.2.c.29 – Cracked stucco at parapet wall (Roof Level)
