# Mystic Pointe Tower 500 Condominium

3530 Mystic Pointe Drive, Aventura, FL 33180

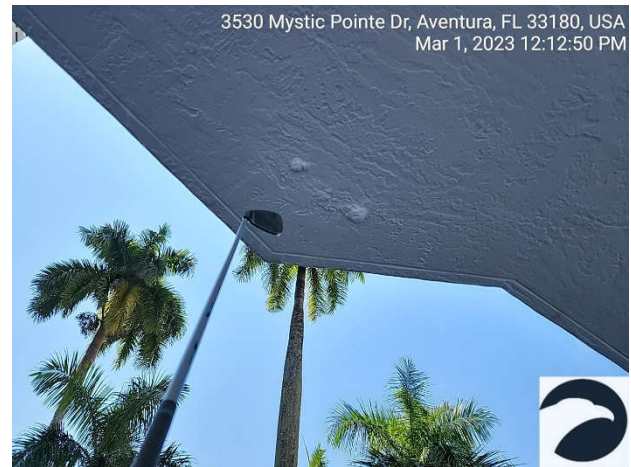
Photo 7.2.c.30 – Cracked stucco and initial stage of detachment at Pool Deck ceiling (Unit 903)

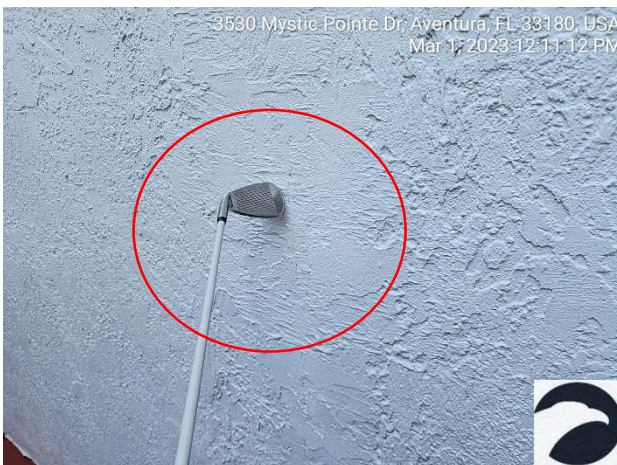
Photo 7.2.c.31 – Stucco delamination, hollow sound at building wall (Pool Deck Level)

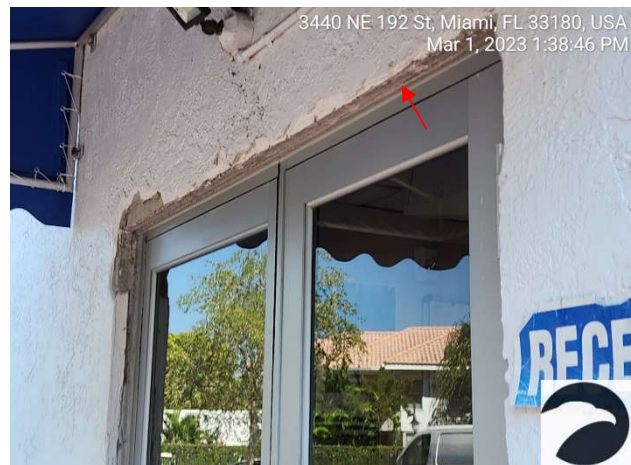
Photo 7.2.c.32 – Missing stucco at entrance door return (West Façade)

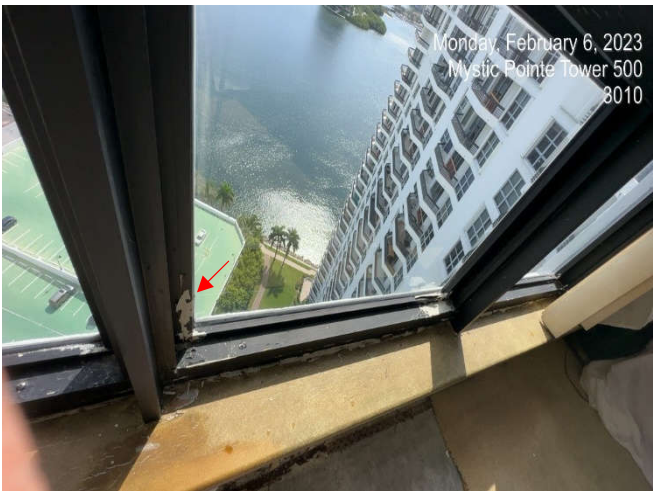
Photo 7.3.a.1 – Paint peeling, water stains noted at the interior side of the unit along the window perimeter (Unit 3010)

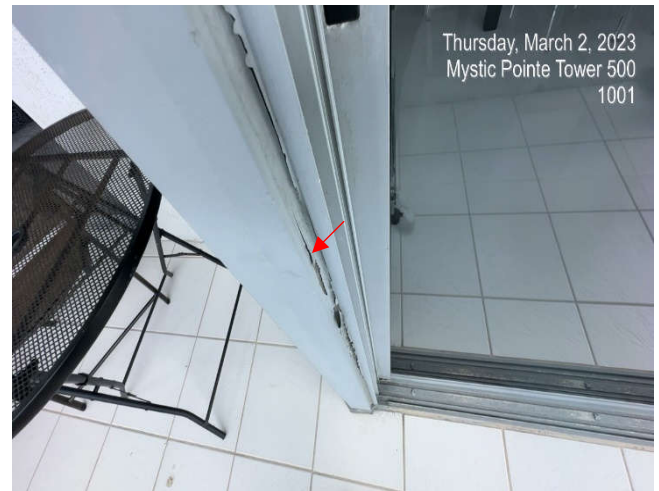
Photo 7.3.a.2 – Paint peeling at the sliding glass door (Unit 1001)

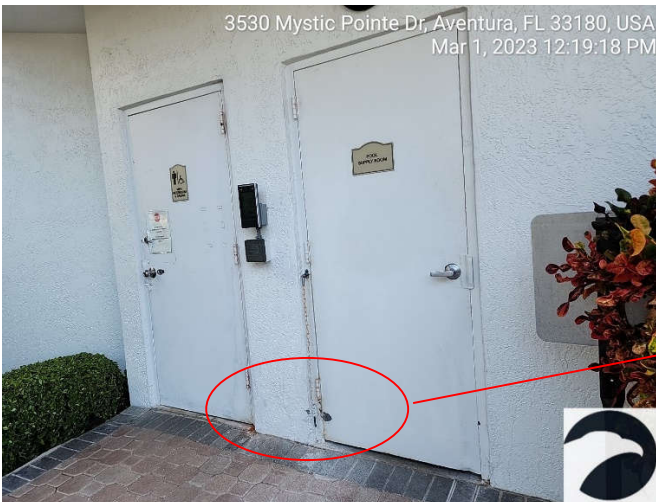
Photo 7.3.a.9 – Corroded doors of the Bathroom and Pool Equipment Room (Ground Level)

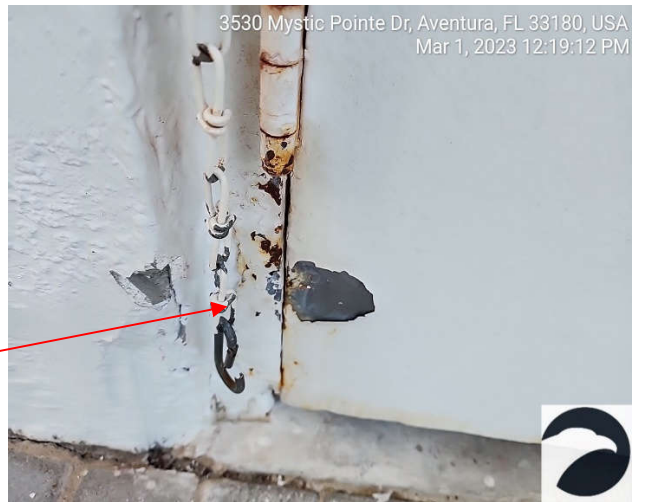
Photo 7.3.a.10 – Delaminated paint at Pool Deck storefront (Ground Level)

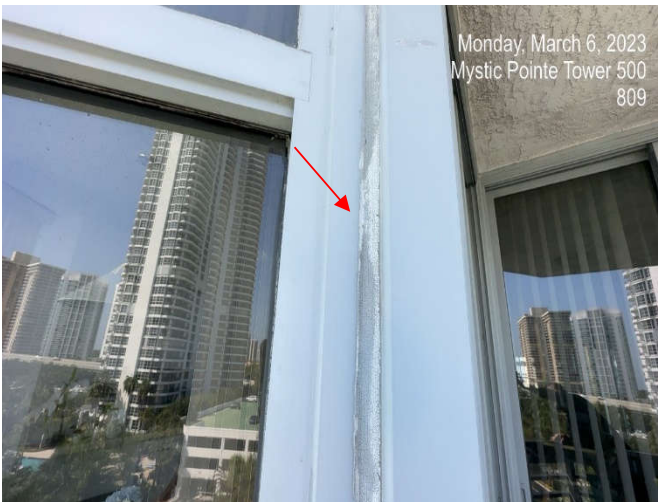
Photo 7.3.b.1 – Deteriorated metal-to-metal caulking at window (Unit 809)

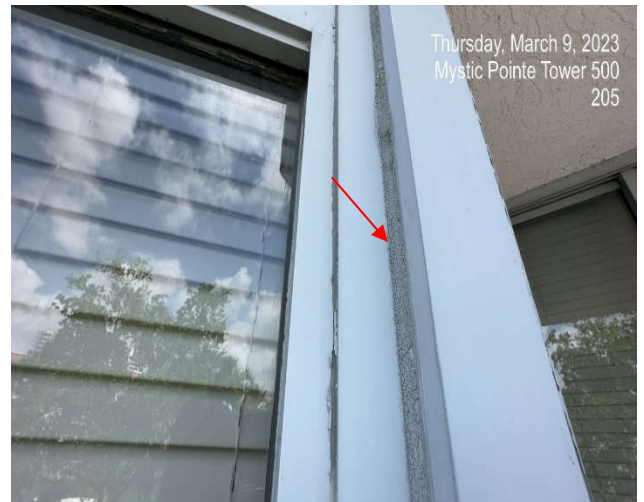
Photo 7.3.b.2 – Deteriorated metal-to-metal caulking at window (Unit 205)

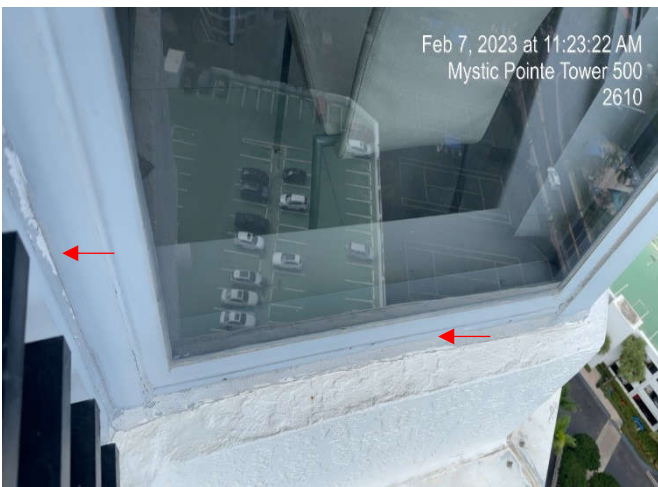
Photo 7.3.b.3 – Cracked and deteriorated stucco-to-metal and metal-to-metal caulking at window (Unit 2610)

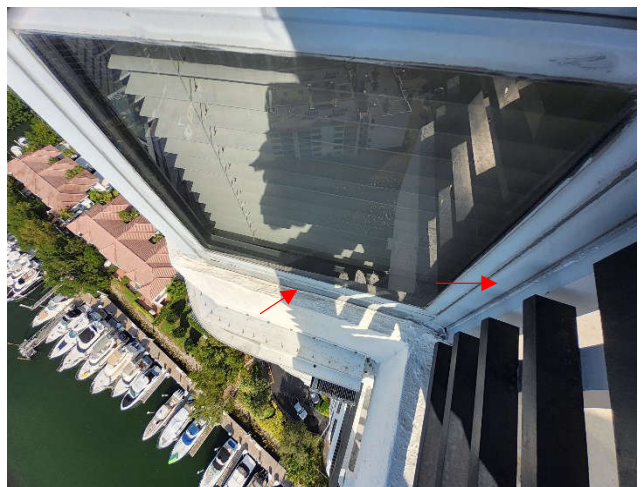
Photo 7.3.b.4 – Cracked and deteriorated stucco-to-metal and metal-to-metal caulking at window (Unit 2805)

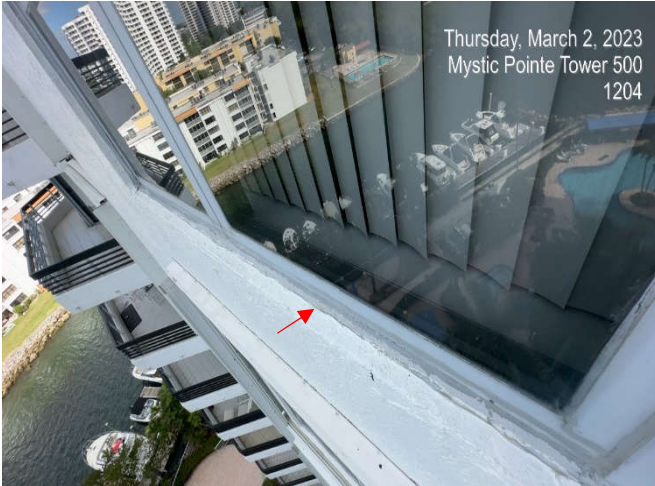
Photo 7.3.b.5 – Cracked and deteriorated stucco-to-metal caulking at window (Unit 723)

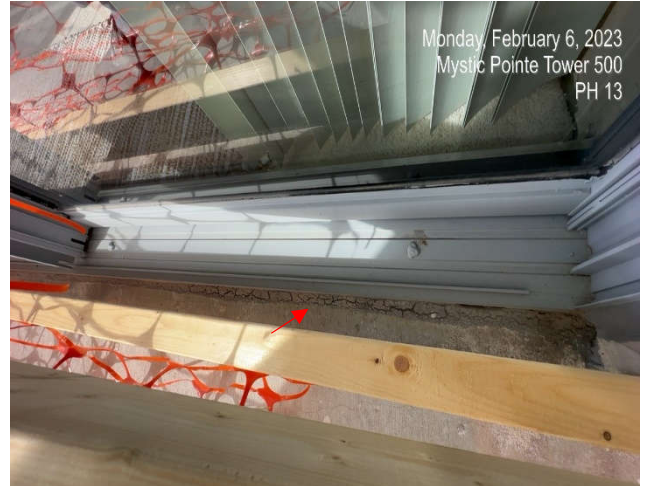
Photo 7.3.b.6 – Cracked and deteriorated stucco-to-metal caulking at the balcony sliding glass door sill (Unit PH 13)

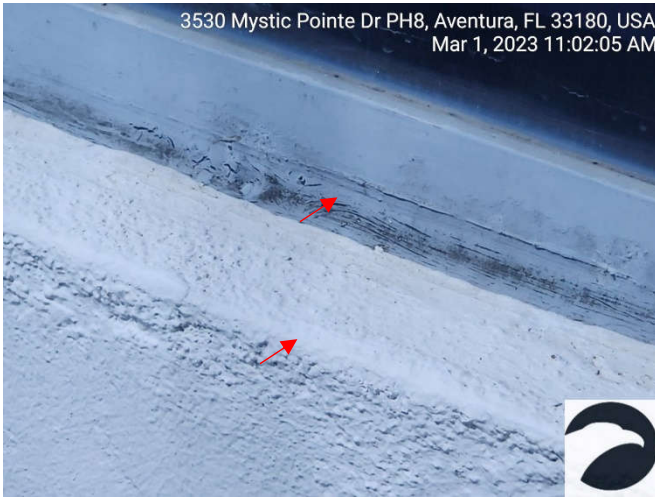
Photo 7.3.b.7 – Deteriorated metal-to-metal sealant at window (Unit 1407)

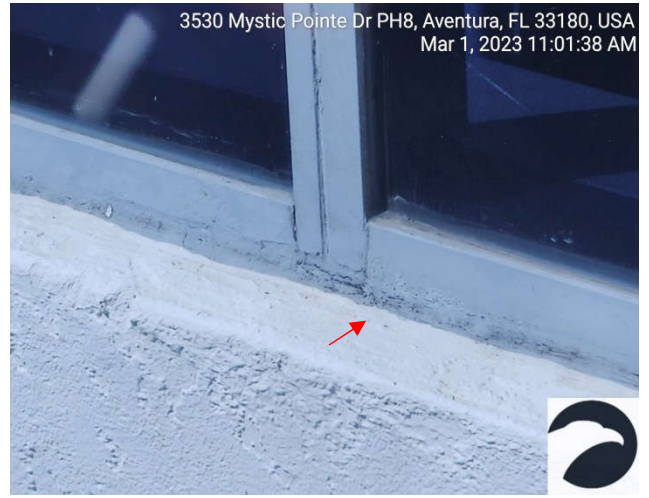
Photo 7.3.b.8 – Deteriorated metal-to-metal sealant at window (Unit PH-8)

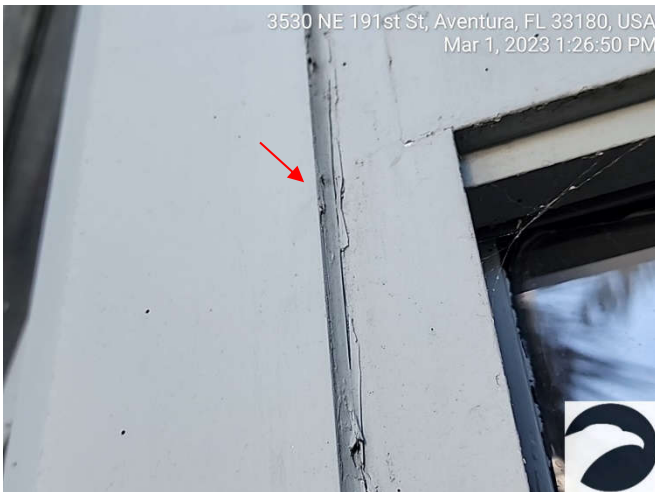
Photo 7.3.b.9 – Deteriorated metal-to-metal sealant at window (Unit 308)

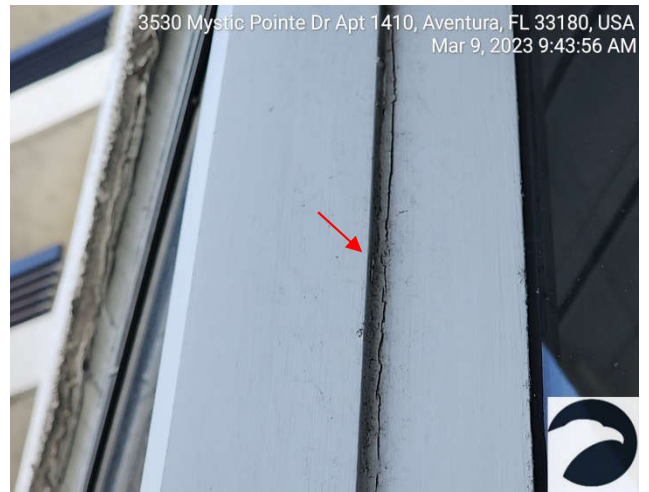
Photo 7.3.b.10 – Cracked metal-to-metal sealant at window (Unit 308)

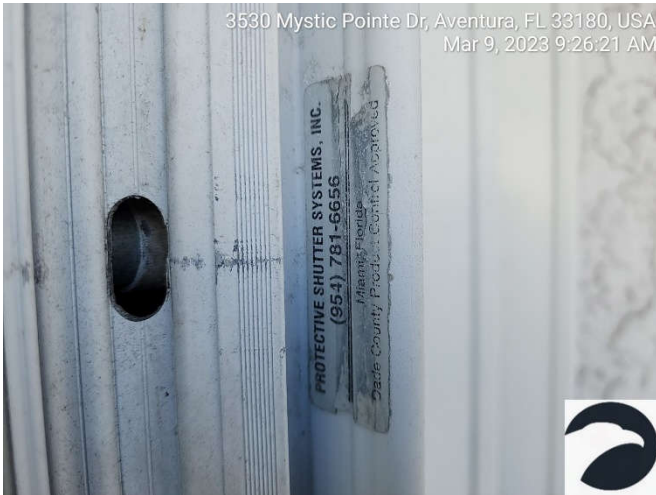
Photo 7.3.c.1 – Typical shutter system (Unit PH-8)

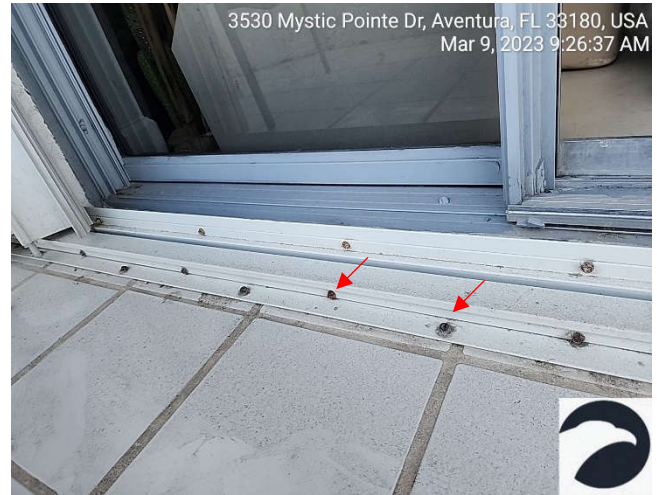
Photo 7.3.c.2 – Corroded anchors of the accordion shutter at sill track (Unit 1418)

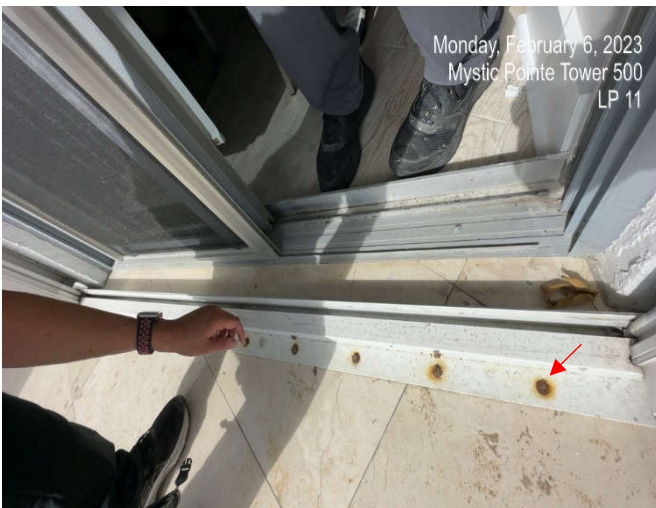
Photo 7.3.c.3 – Corroded anchors of the accordion shutter at sill track (Unit LP 11)

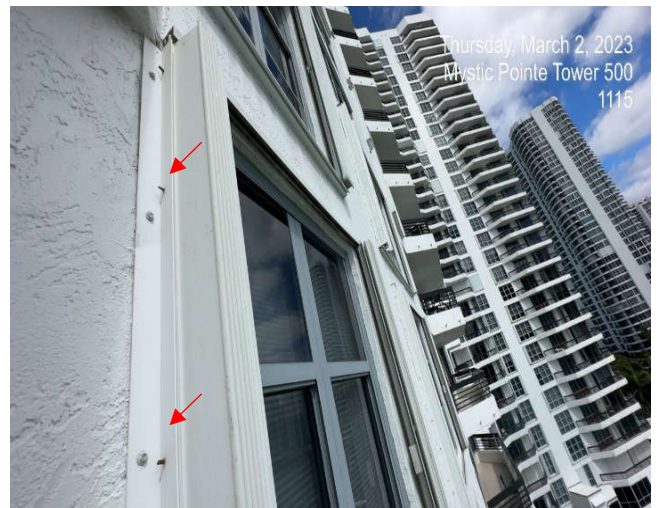
Photo 7.3.c.4 – Corroded anchors of the accordion shutter at jamb track (Unit 1115)

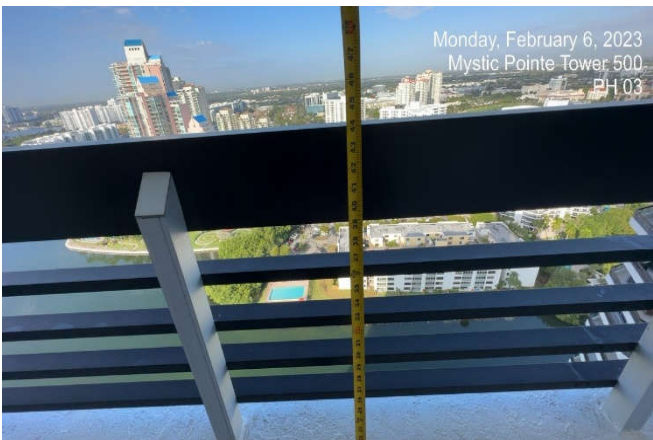
Photo 7.4.1 – Typical balcony railing height 44” from the finished floor slab

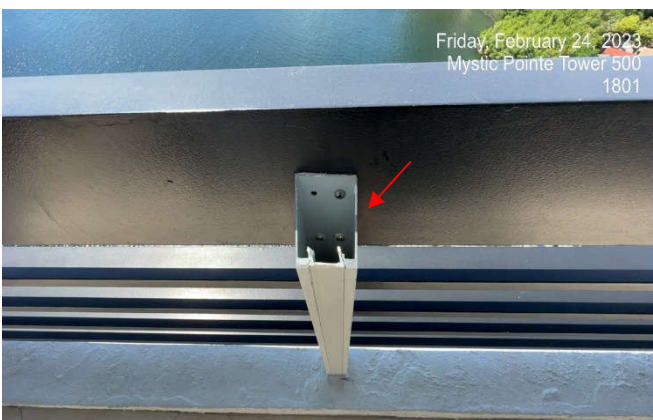
Photo 7.4.3 – Missing railing post cap (Unit 1801)

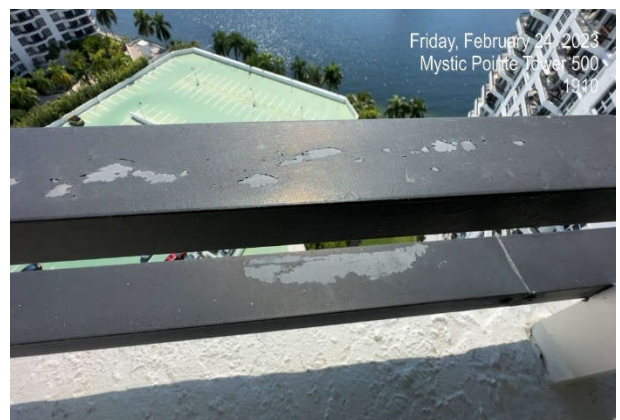
Photo 7.4.4 – Peeling paint at the balcony railing (Unit 1910)

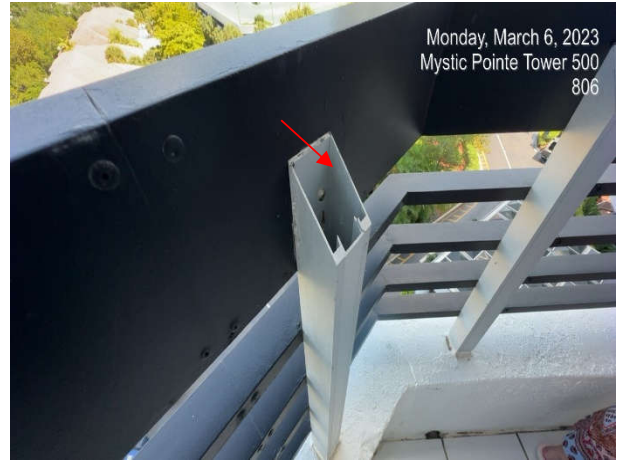
Photo 7.4.14 – Missing railing post cap (Unit 806)

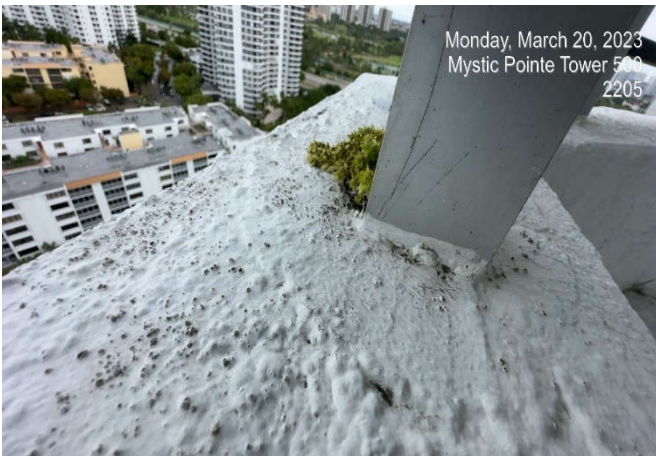
Photo 7.8.15 – Evidence of mold, biological growth at railing post pocket (Unit 2205)

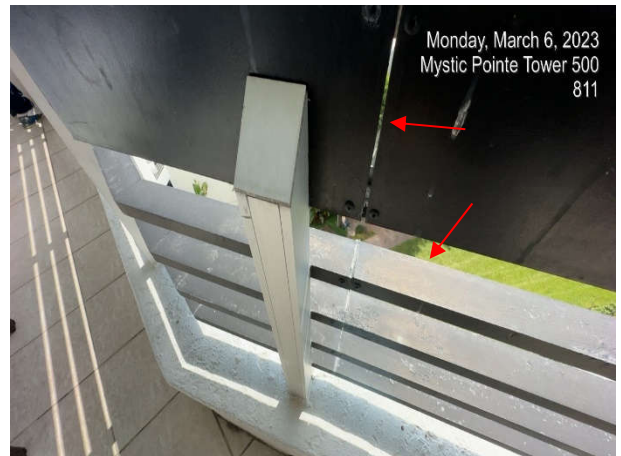
Photo 7.8.16 – Pitting, blisters, and gap between connection at the railing (Unit 811)

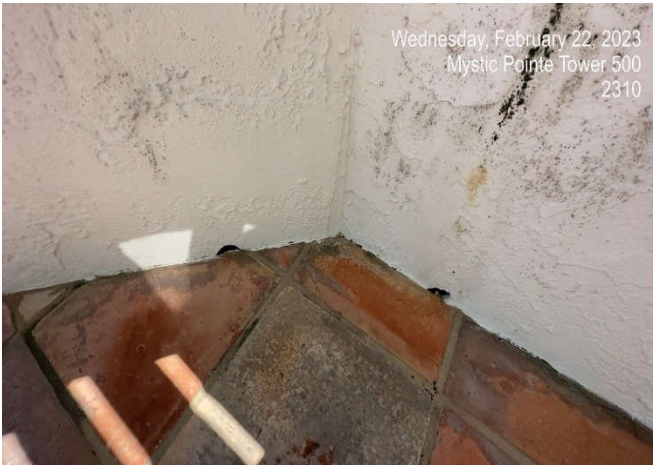
Photo 7.5.1 – Blocked scupper by tile, not conducive of proper drainage at balcony (Unit 2310)

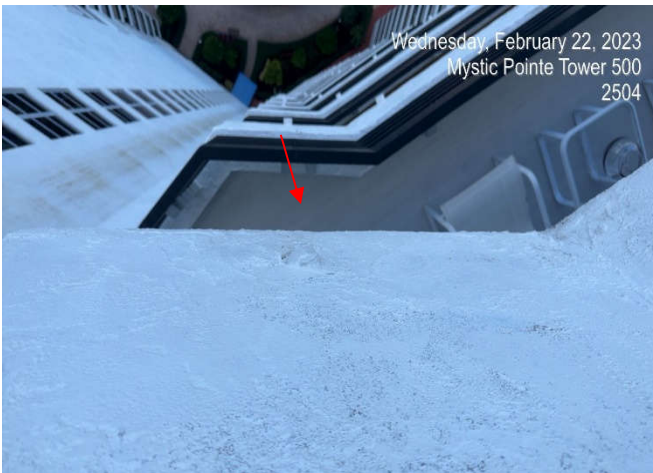
Photo 7.5.3 – Broken scupper at the balcony (Unit 2504)

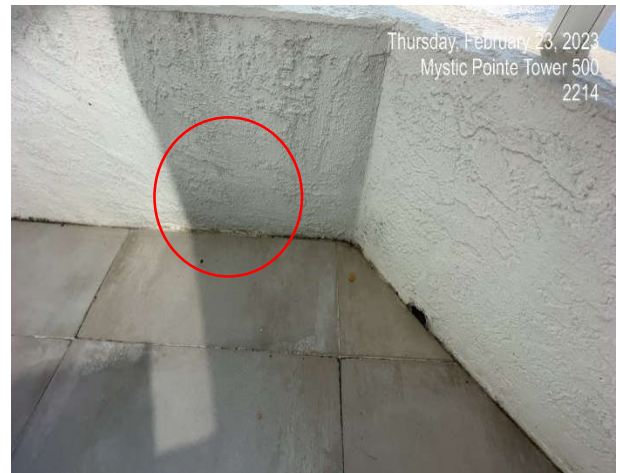
Photo 7.5.4 – Missing scupper hole (Unit 2214)

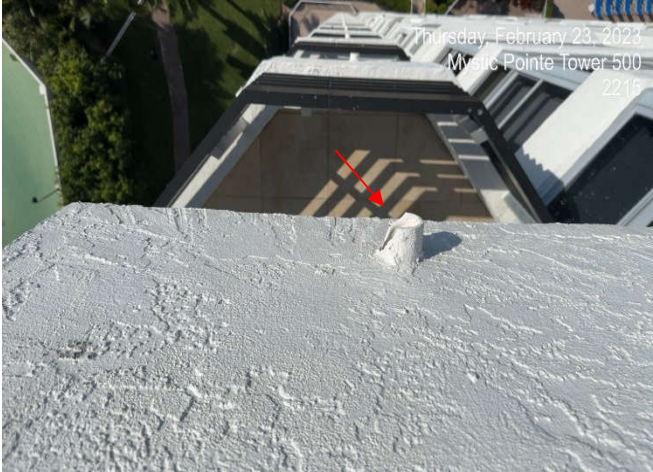
Photo 7.5.5 – Broken scupper (Unit 2215)

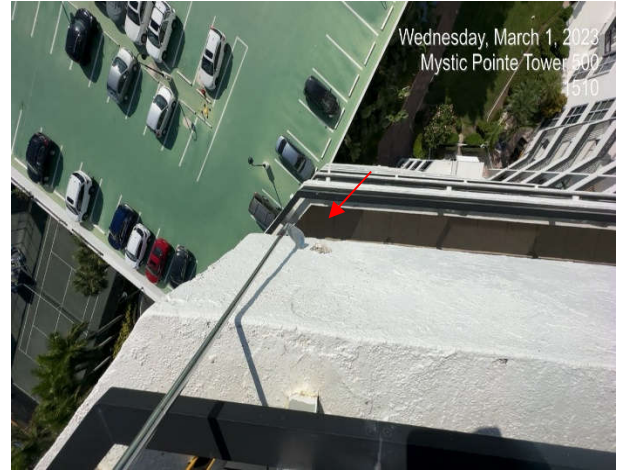
Photo 7.5.6 – Broken scupper (Unit 1510)

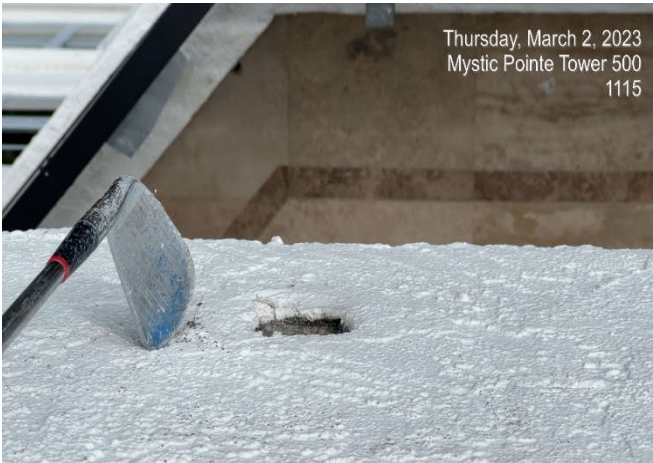
Photo 7.5.7 – Missing scupper (Unit 1115)

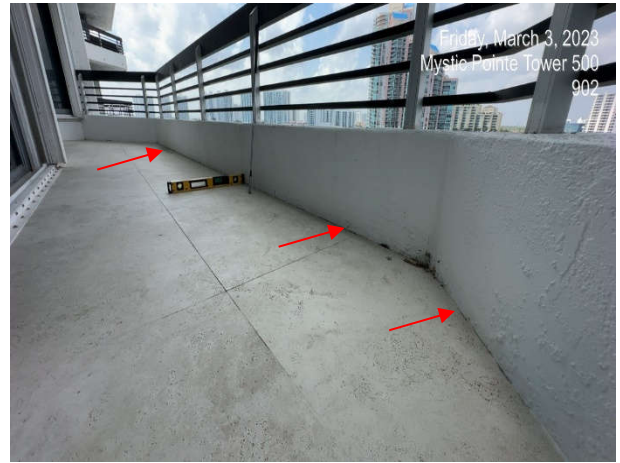
Photo 7.5.8 – Blocked scuppers (Unit 902)

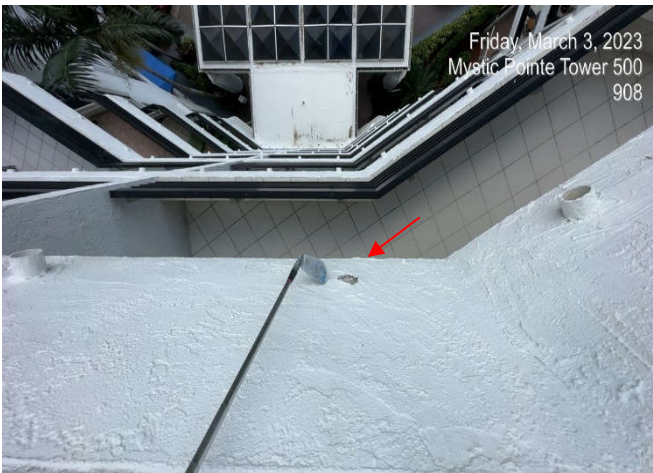
Photo 7.5.9 – Missing scupper (Unit 908)

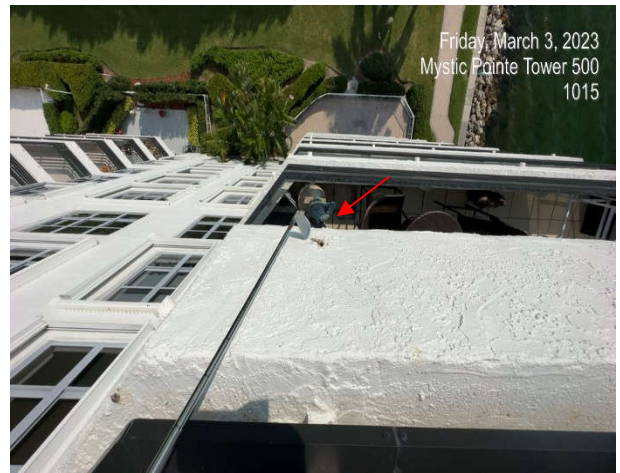
Photo 7.5.10 – Missing scupper (Unit 1015)

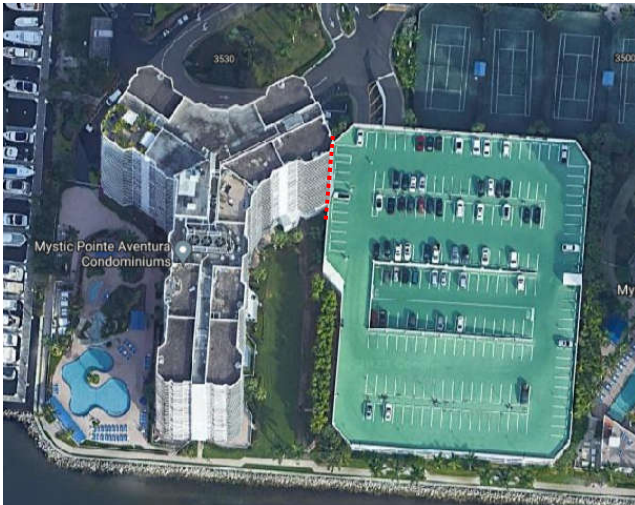
Photo 7.6.1 – Existing expansion joint course between building and garage (Aerial view)

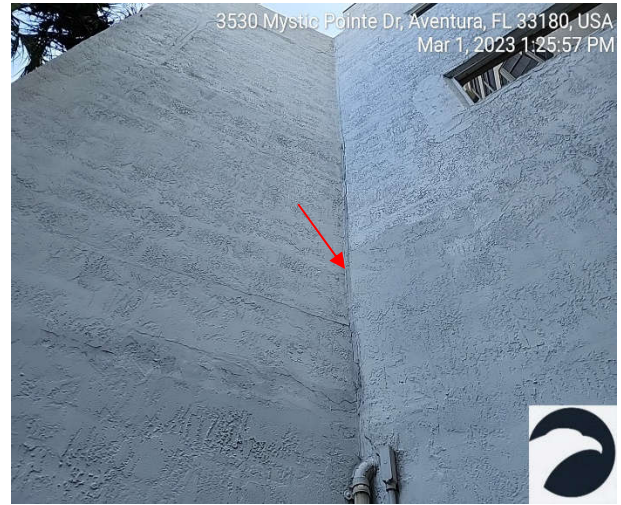
Photo 7.6.2 – Deteriorated expansion joint at the building facade (Lobby Level)

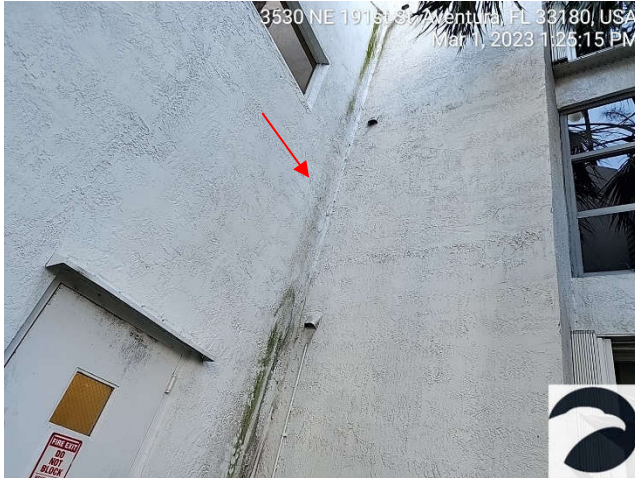
Photo 7.6.3 – Deteriorated expansion joint, with biological growth, at the building façade (Lobby Level)

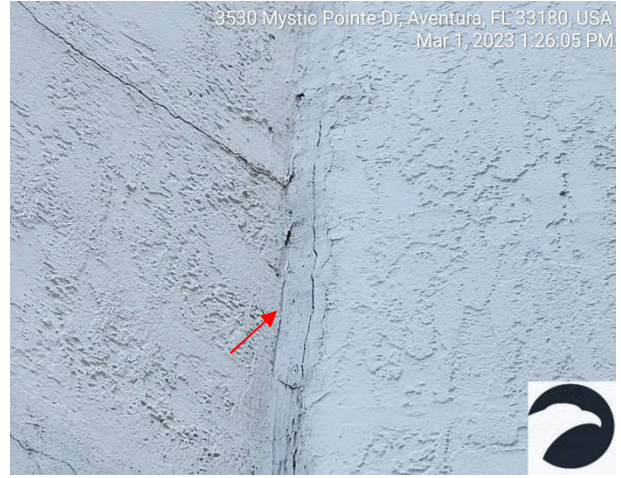
Photo 7.6.4 – Cracked expansion joint at the building façade (Lobby Level)

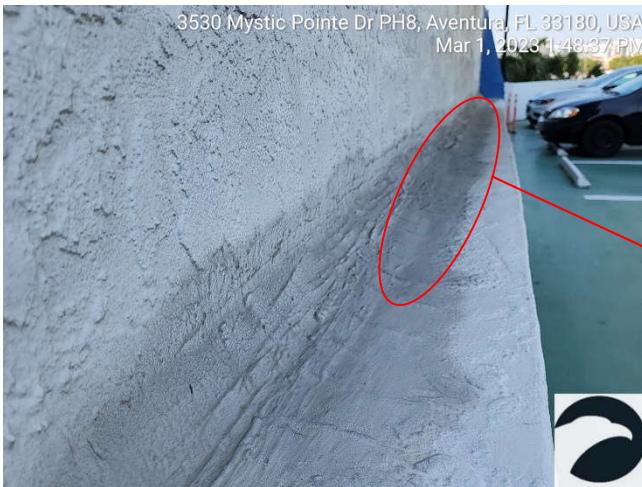
Photo 7.6.5 – Deteriorated and cracked expansion joint at the building façade (Garage Level 4)

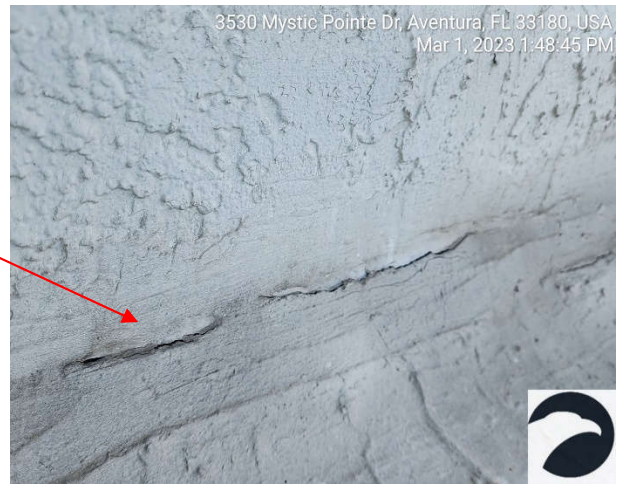
Photo 7.6.6 – Cracked expansion joint at the building façade (Garage Level 4)

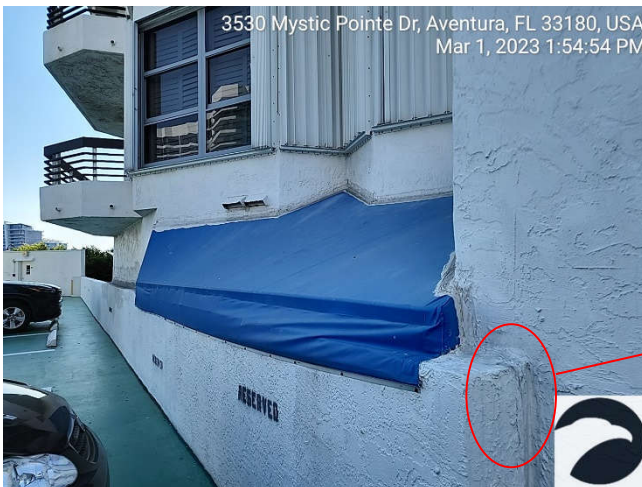
Photo 7.6.7 – Cracked expansion joint at the building façade (Garage Level 4)

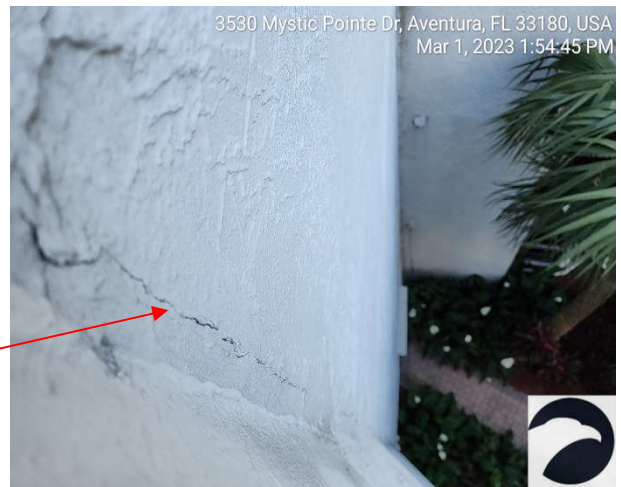
Photo 7.6.8 – Cracked expansion joint at the building façade (Level 4)

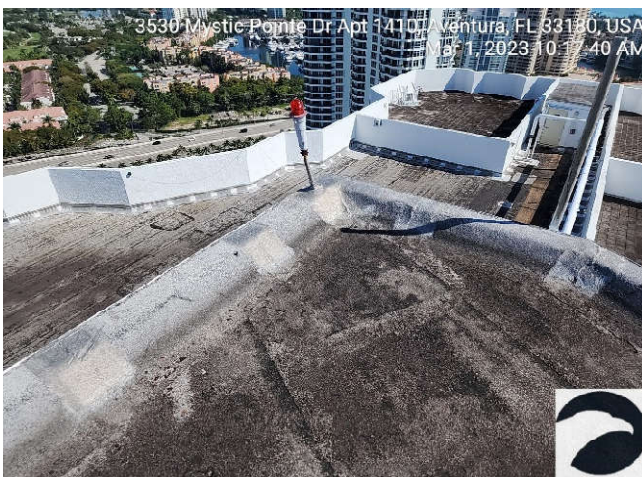
Photo 7.7.1 – Existing roofing system in poor condition (Upper Roof)

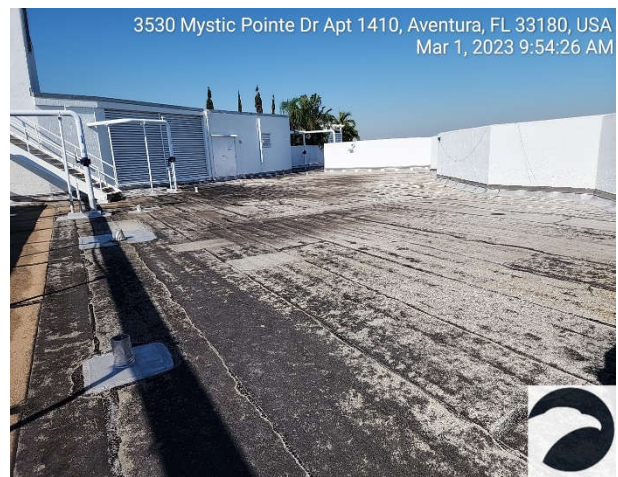
Photo 7.7.2 – Existing roofing system membrane in poor condition (Main Roof)

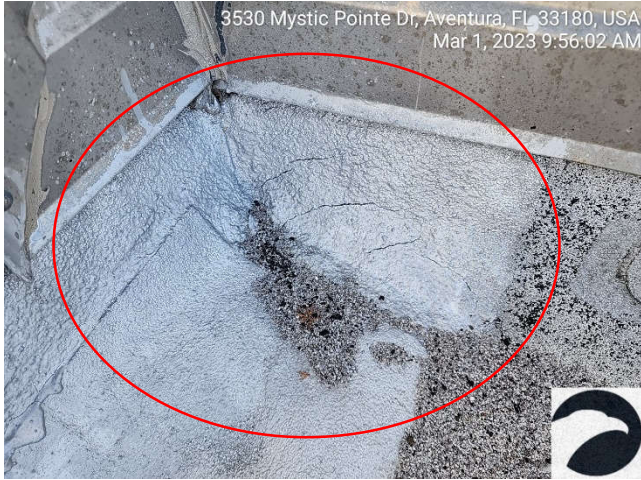
Photo 7.7.3 – ?????????????? (roof)

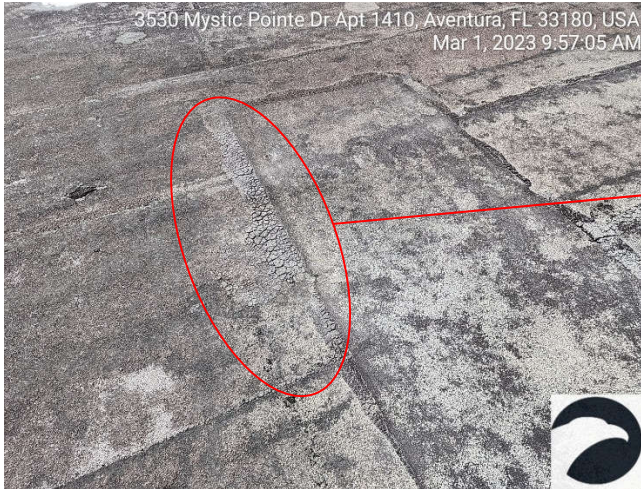
Photo 7.7.5 – Deteriorated and cracked roofing membrane at previous repair (Main Roof)

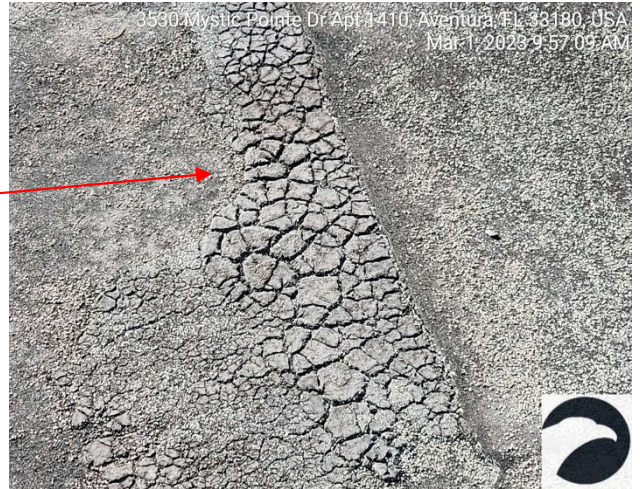
Photo 7.7.6 – Deteriorated and cracked roofing membrane (Main Roof)

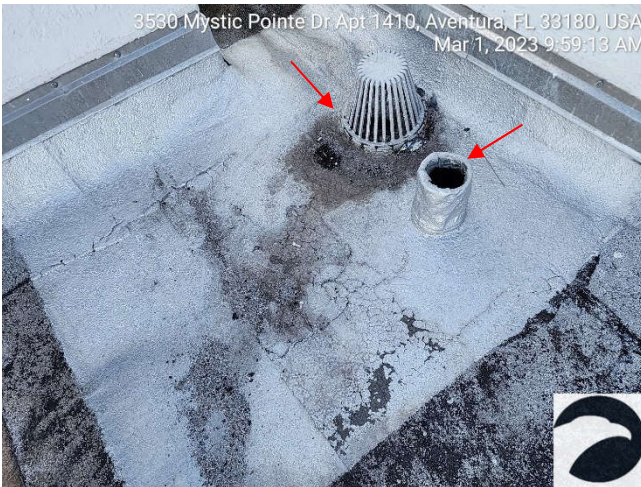
Photo 7.7.7 – Deteriorated previous repair performed around the drain (Main Roof)

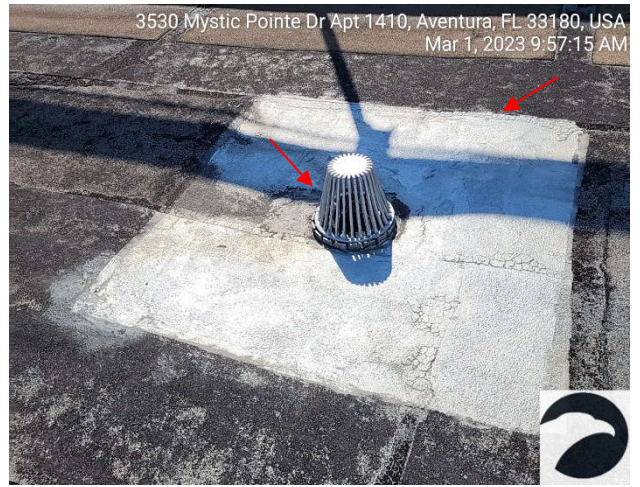
Photo 7.7.8 – Deteriorated previous repair performed around the drain (Main Roof)

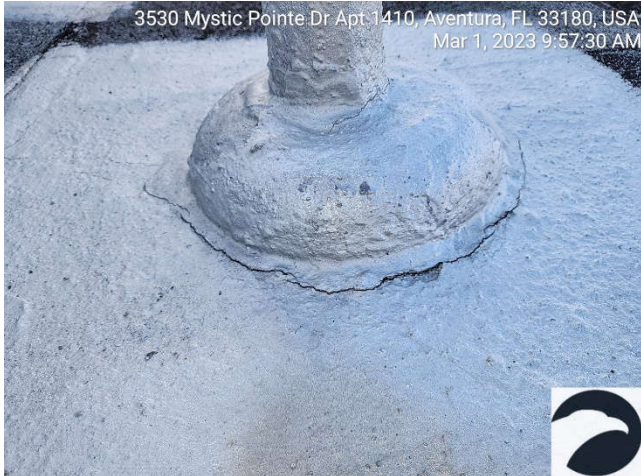
Photo 7.7.9 – Cracked and deteriorated sealant at the pitch pan and previous repair performed (Main Roof)

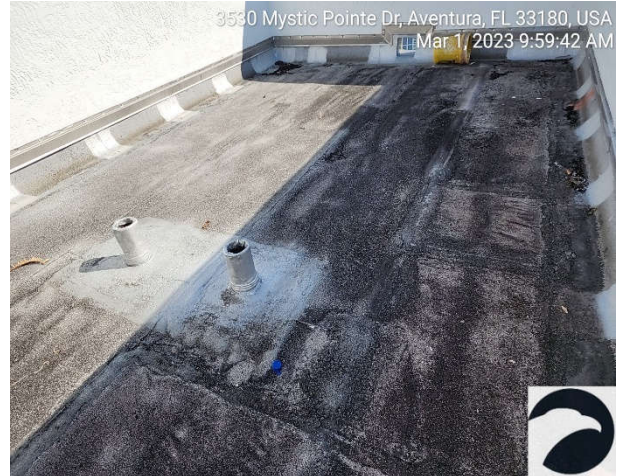
Photo 7.7.10 – Previous repair performed at multiple areas of the roof (Main Roof)

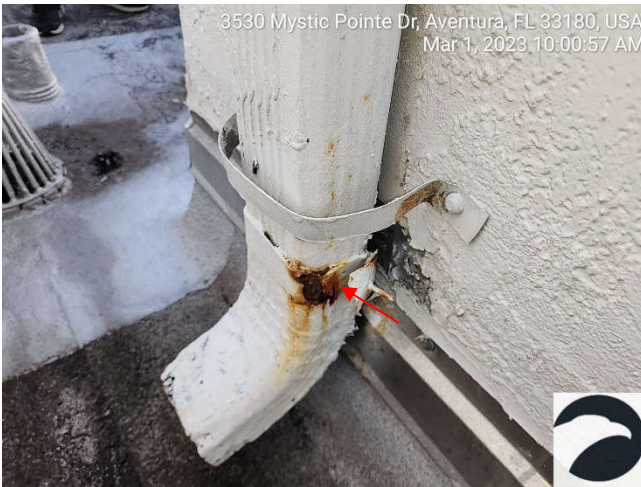
Photo 7.7.11 – Corroded downspout (Main Roof)

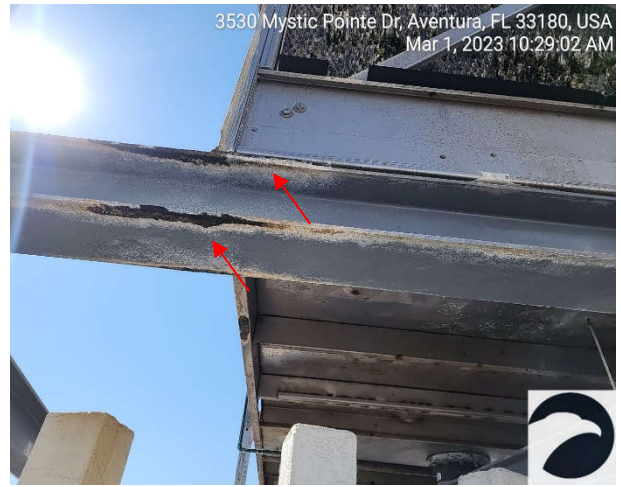
Photo 7.7.12 – Mild corrosion at the cooling tower supports (Main Roof)

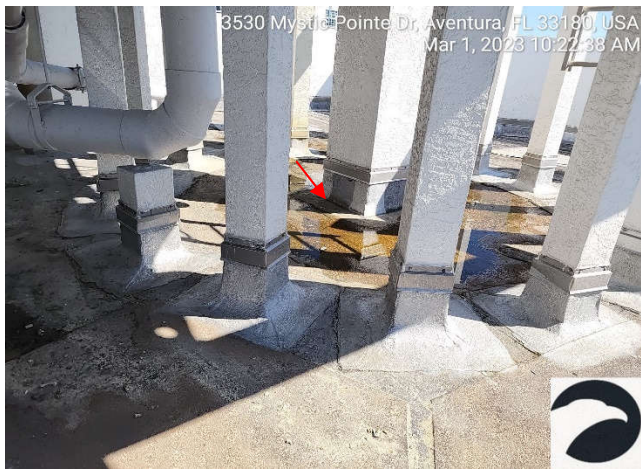
Photo 7.7.13 – Ponding water at the cooling tower and columns from the previous cooling tower structures (Main Roof)

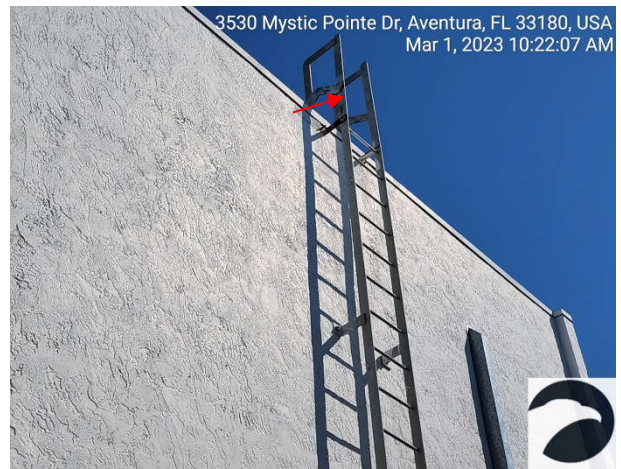
Photo 7.7.14 – Corroded ladder (Main Roof)

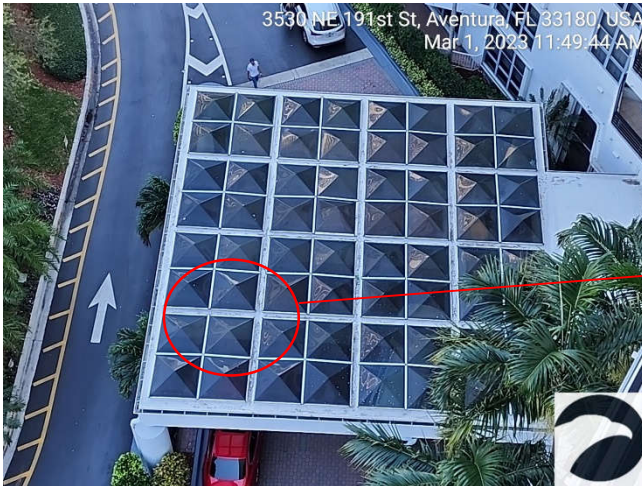
Photo 7.7.15 – Existing skylight roofing system in fair condition (Lower Roof)

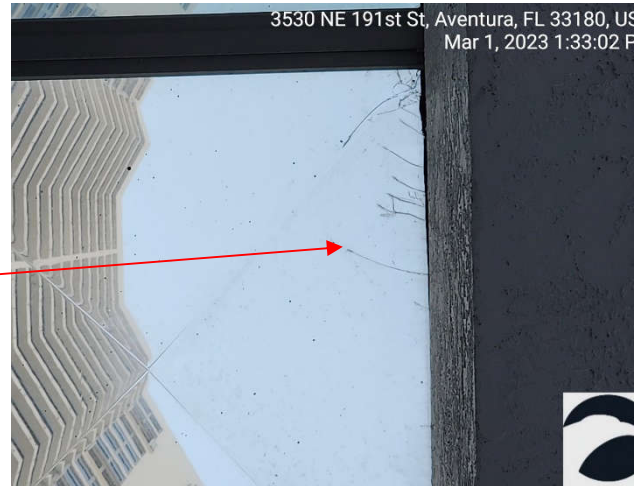
Photo 7.7.16 – Cracked panel at skylight system (Lower Roof)

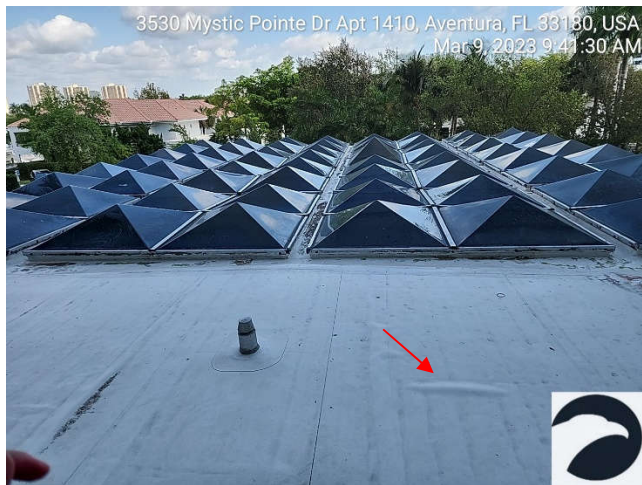
Photo 7.7.17 – Roofing system appears to be TPO, in fair condition, and wrinkle in membrane noted (Lower Roof)

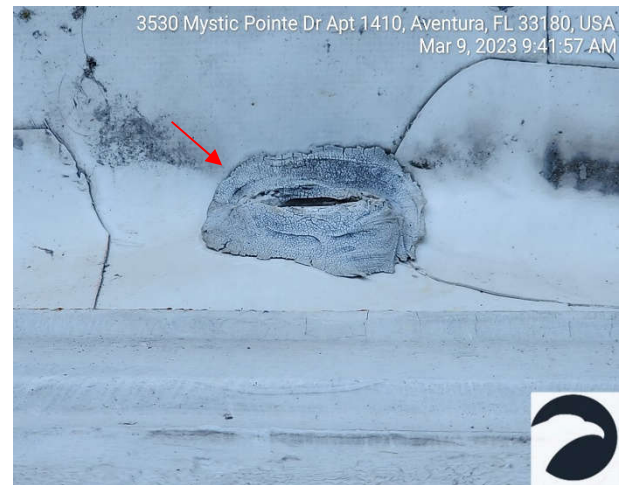
Photo 7.7.18 – Cracked sealant around the penetration of the roofing system (Lower Roof)

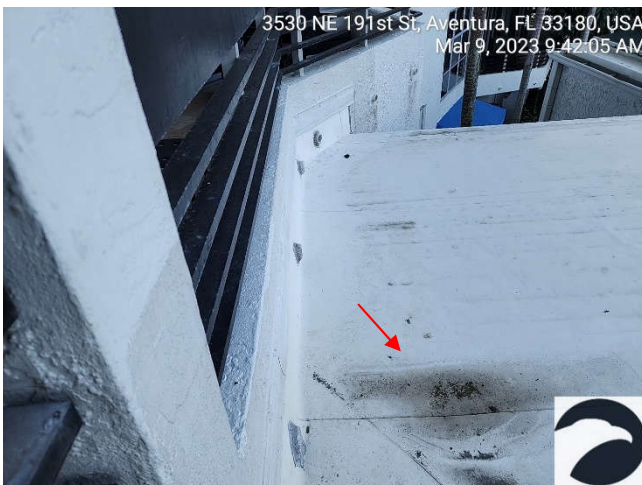
Photo 7.7.19 – Ponding water at the Lower Roof area

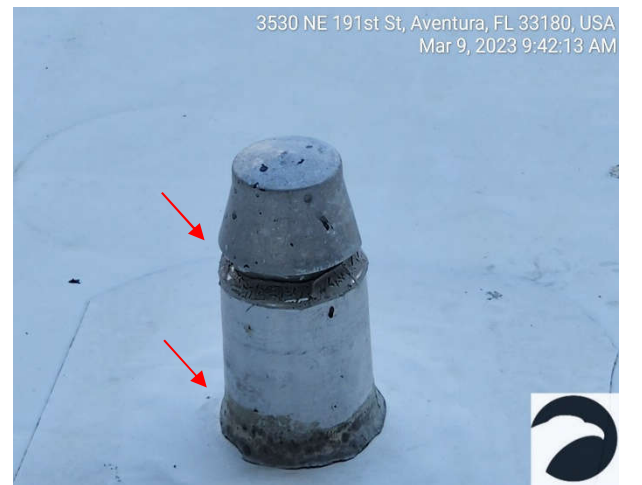
Photo 7.7.20 – Deteriorated and cracked sealant around the penetration of the roofing system (Lower Roof)

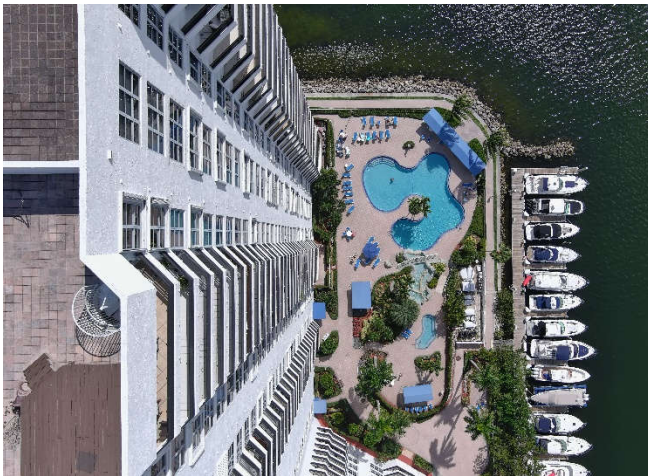
Photo 7.8.1 – Overall view of the Pool Deck in fair to poor condition (from Drone)

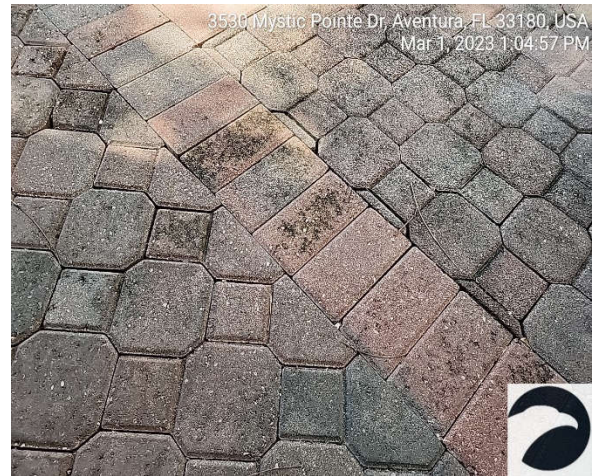
Photo 7.8.2 – Stained pavers at the Pool Deck

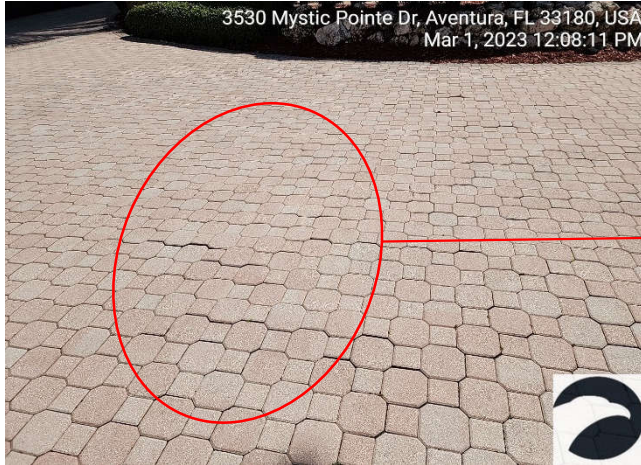
Photo 7.8.3 – Uneven pavers at the Pool Deck

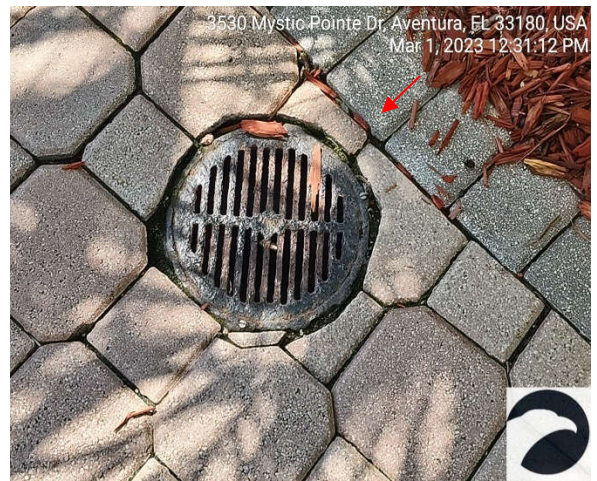
Photo 7.8.8 – Corroded drain cover at the Pool Deck

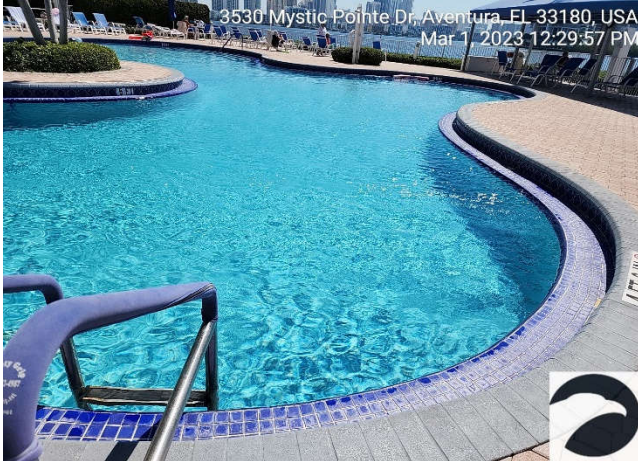
Photo 7.8.9 – Overall view of the pool in fair condition (Pool Deck Level)

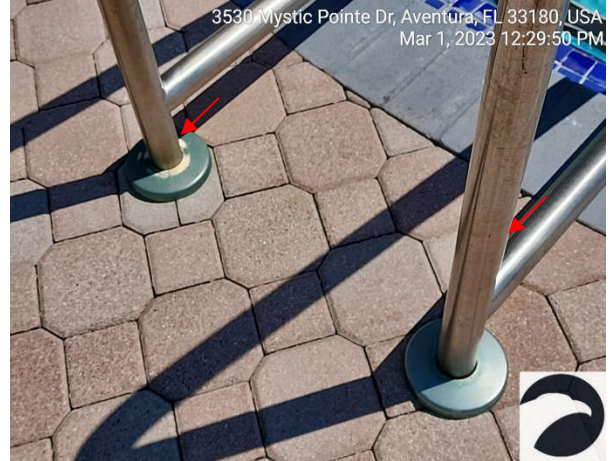
Photo 7.8.10 – Corroded pool railing (Pool Deck Level)

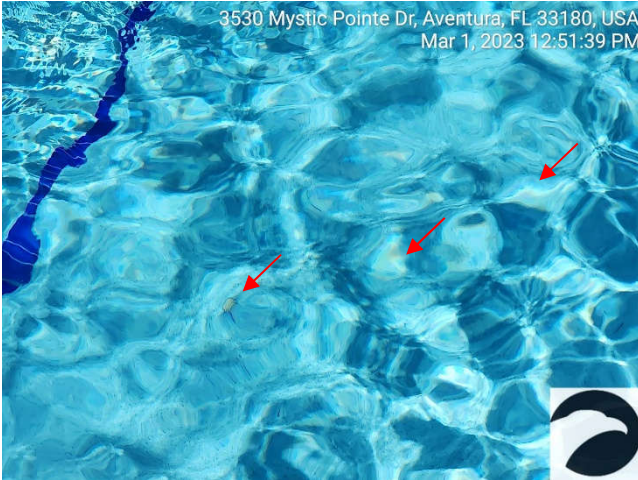
Photo 7.8.11 – Deteriorated finish surface at pool (Pool Deck Level)

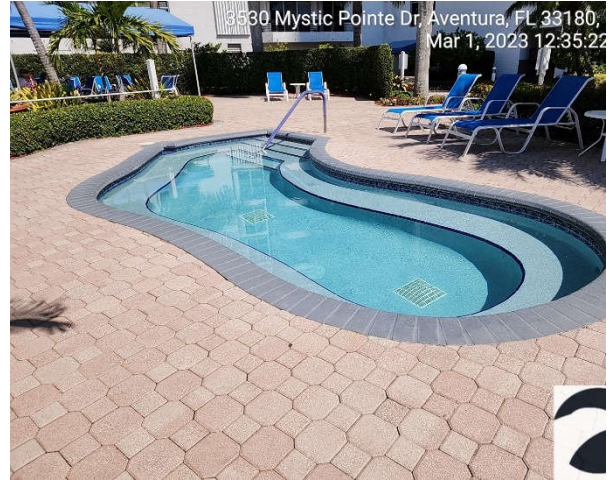
Photo 7.8.12 – Overall view of the jacuzzi in fair condition (Pool Deck Level)
