# Mystic Pointe Tower 500 Condominium

3530 Mystic Pointe Drive, Aventura, FL 33180

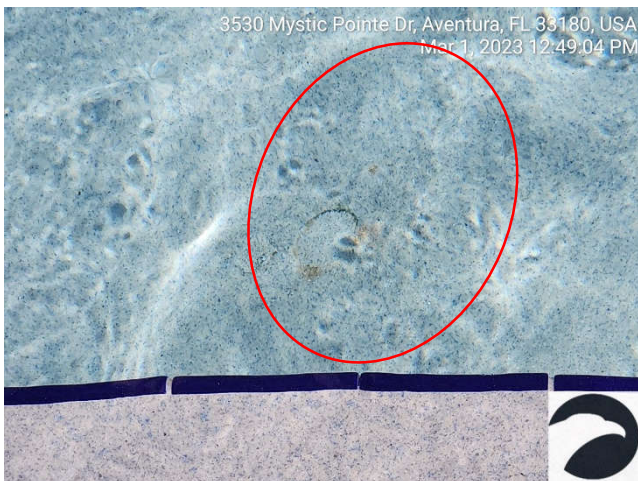
Photo 7.8.13 – Deteriorated finish surface at jacuzzi (Pool Deck Level)

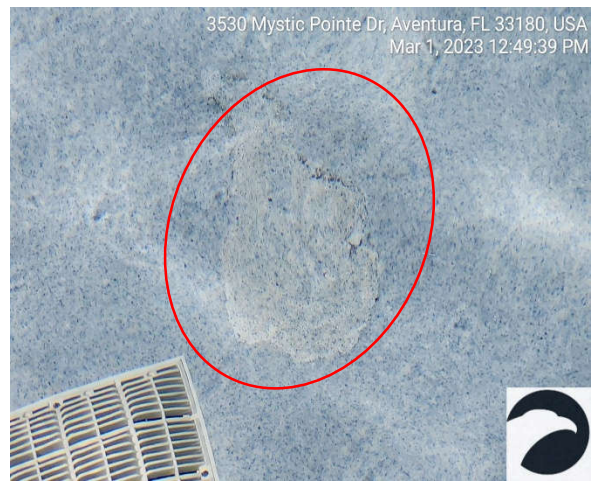
Photo 7.8.14 – Deteriorated finish surface at jacuzzi (Pool Deck Level)
